ITEM # 309816

Customer:
Job Name:
Title: #329A 3/8" Rib 2" OC Vertical

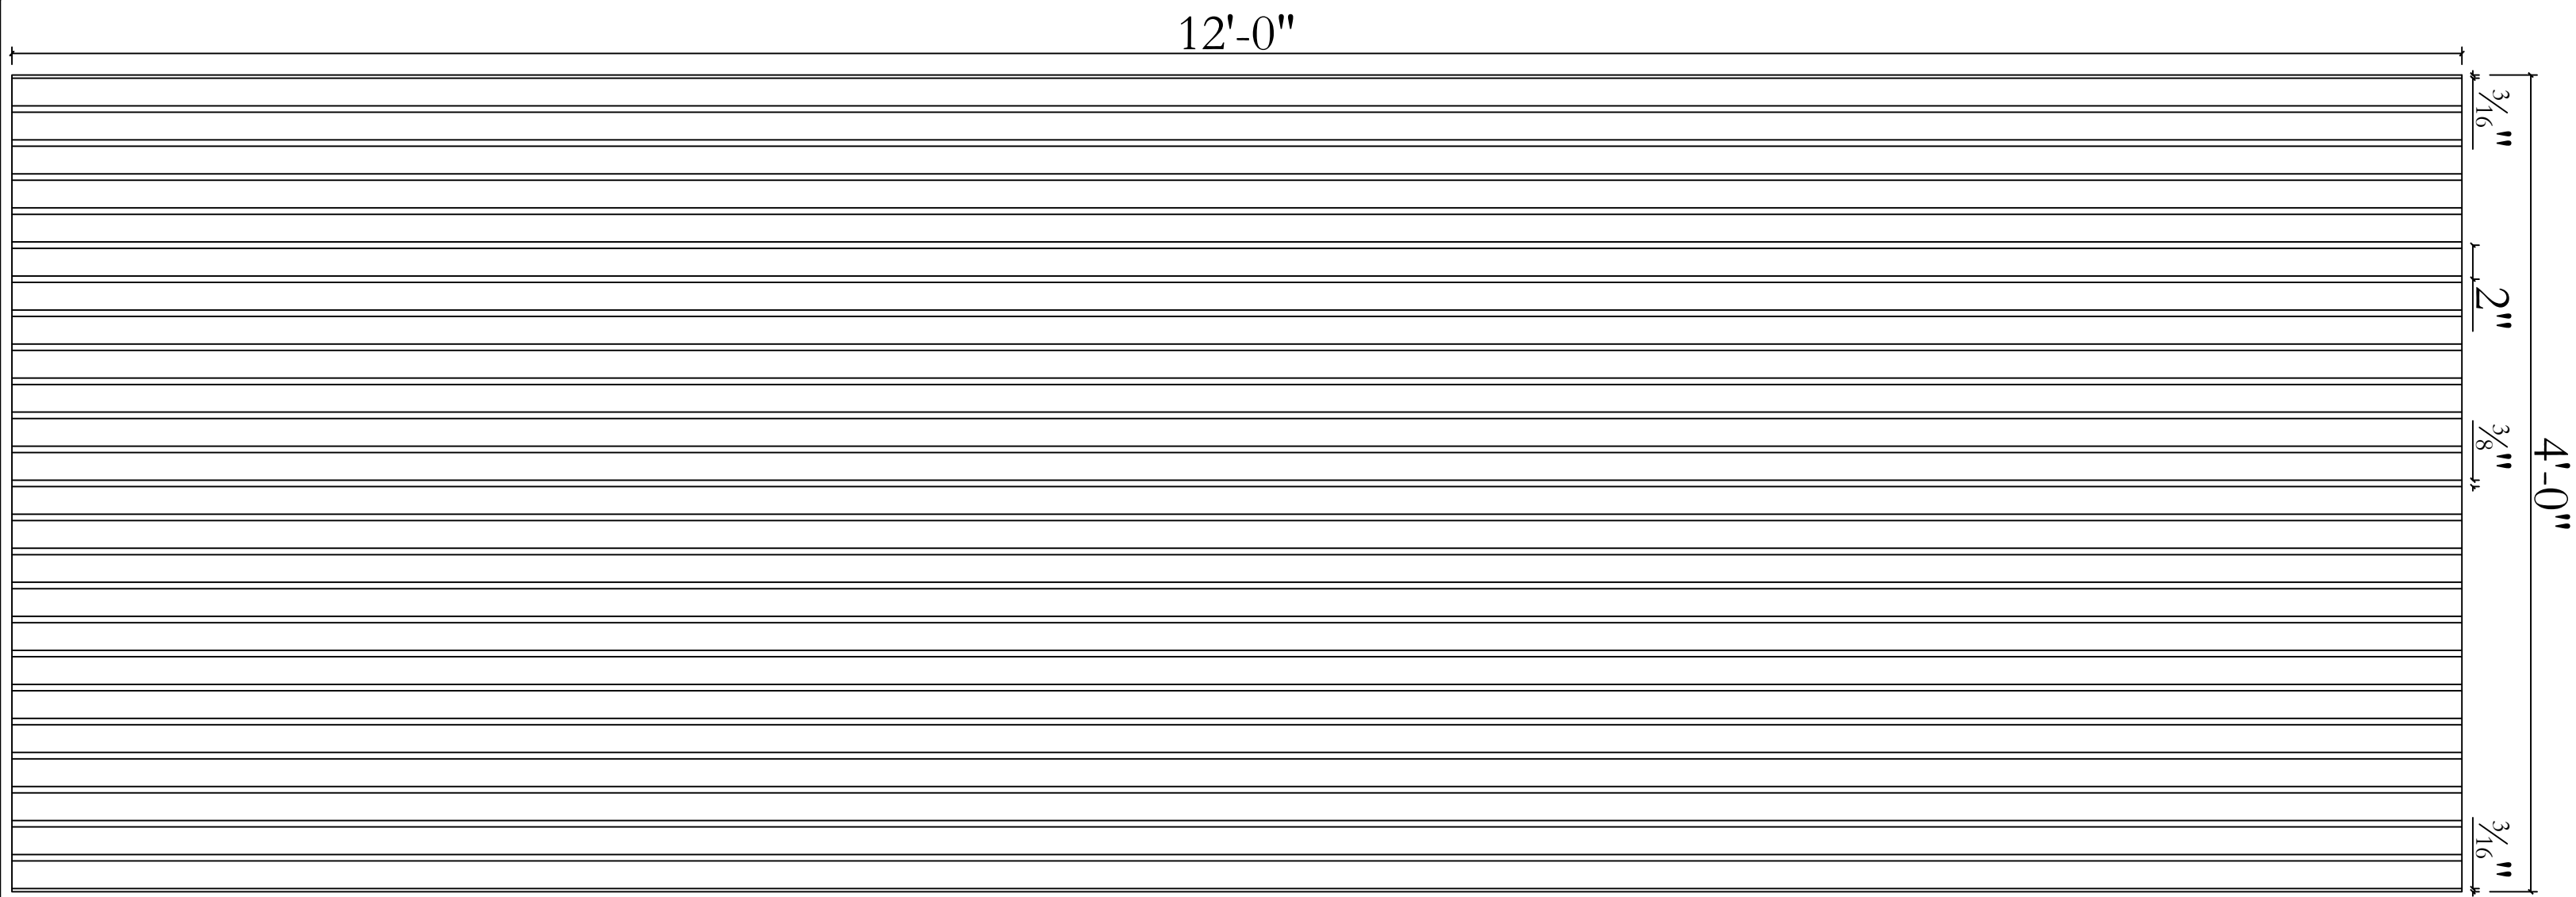
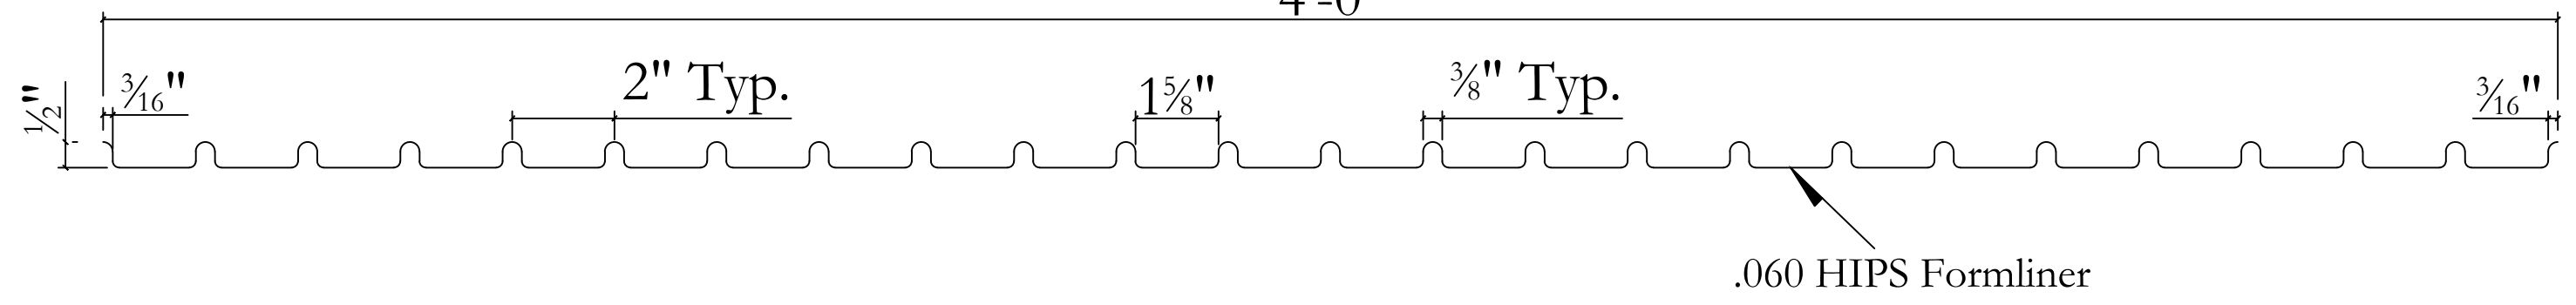
Typical Section
4'-0"

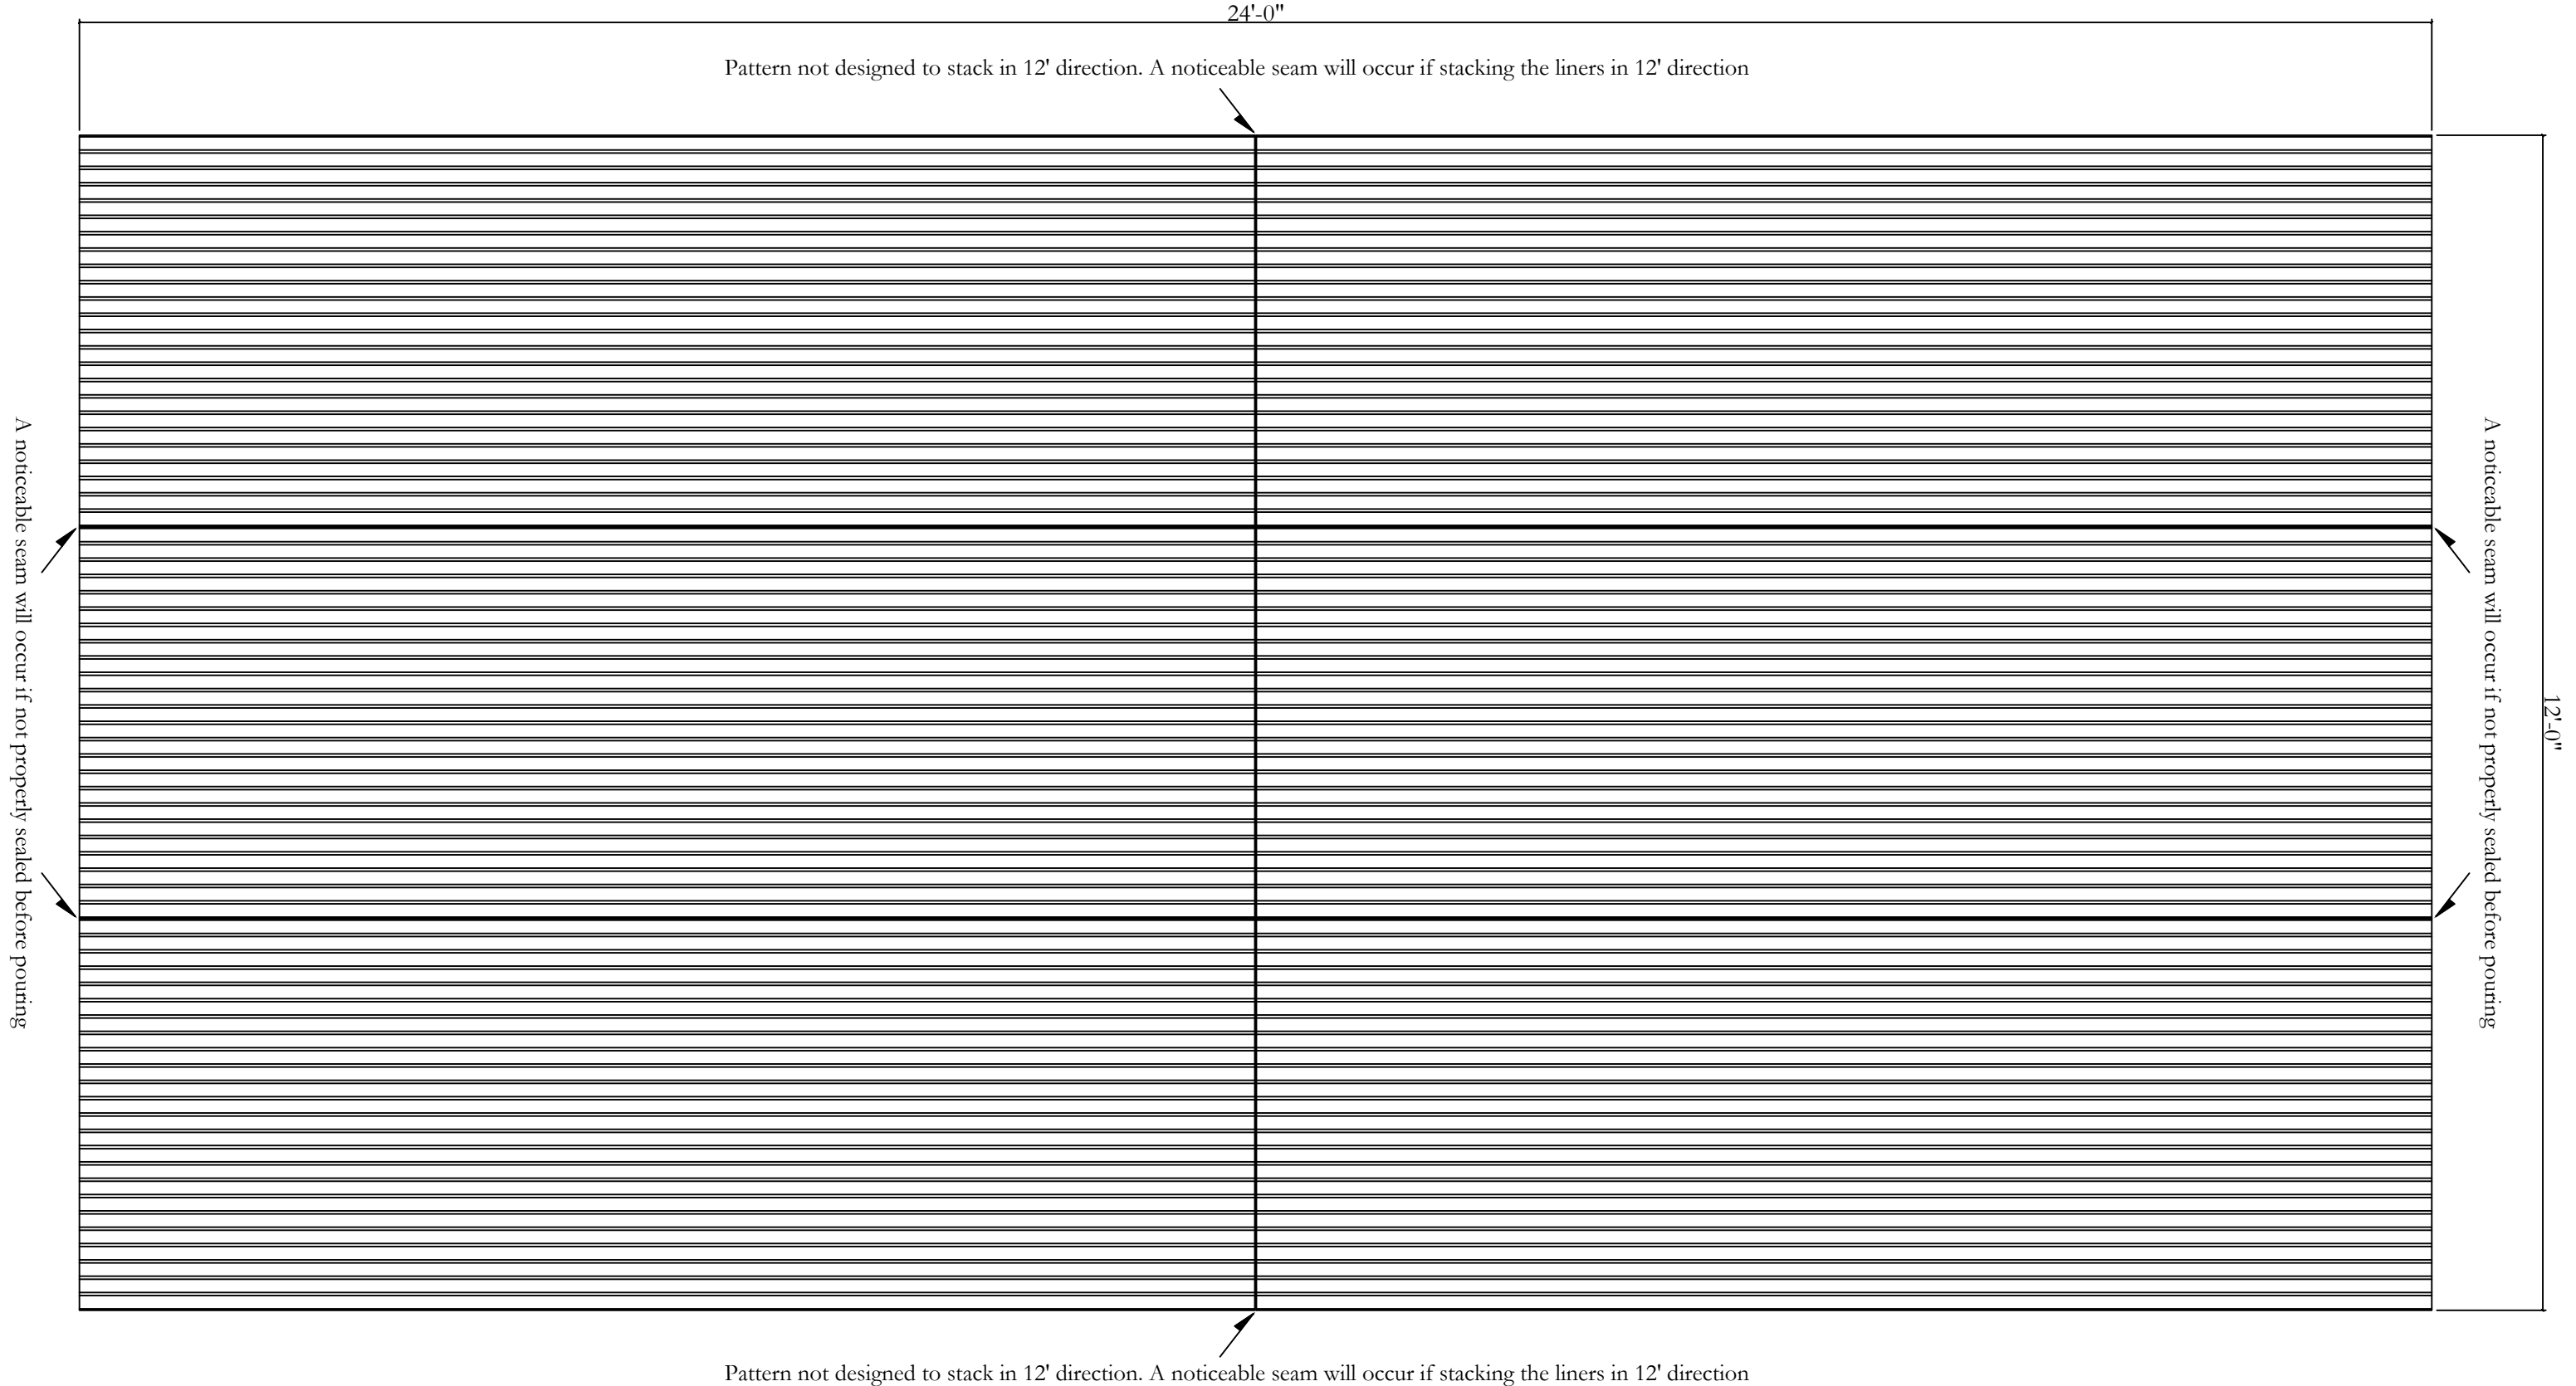
Customer:	Drawn By:	Date:
Job Name:	Approved By:	Date:
Title:	Scale: None	Tolerance: ±3/16
#329A 3/8" Rib 2" OC Vertical Assembled	Page: 2	Drawing Number:
