ITEM # 305831

| <p>309 1" Light Textured Flute</p> | | <p>Page:</p> | <p>Drawing Number:</p> | |

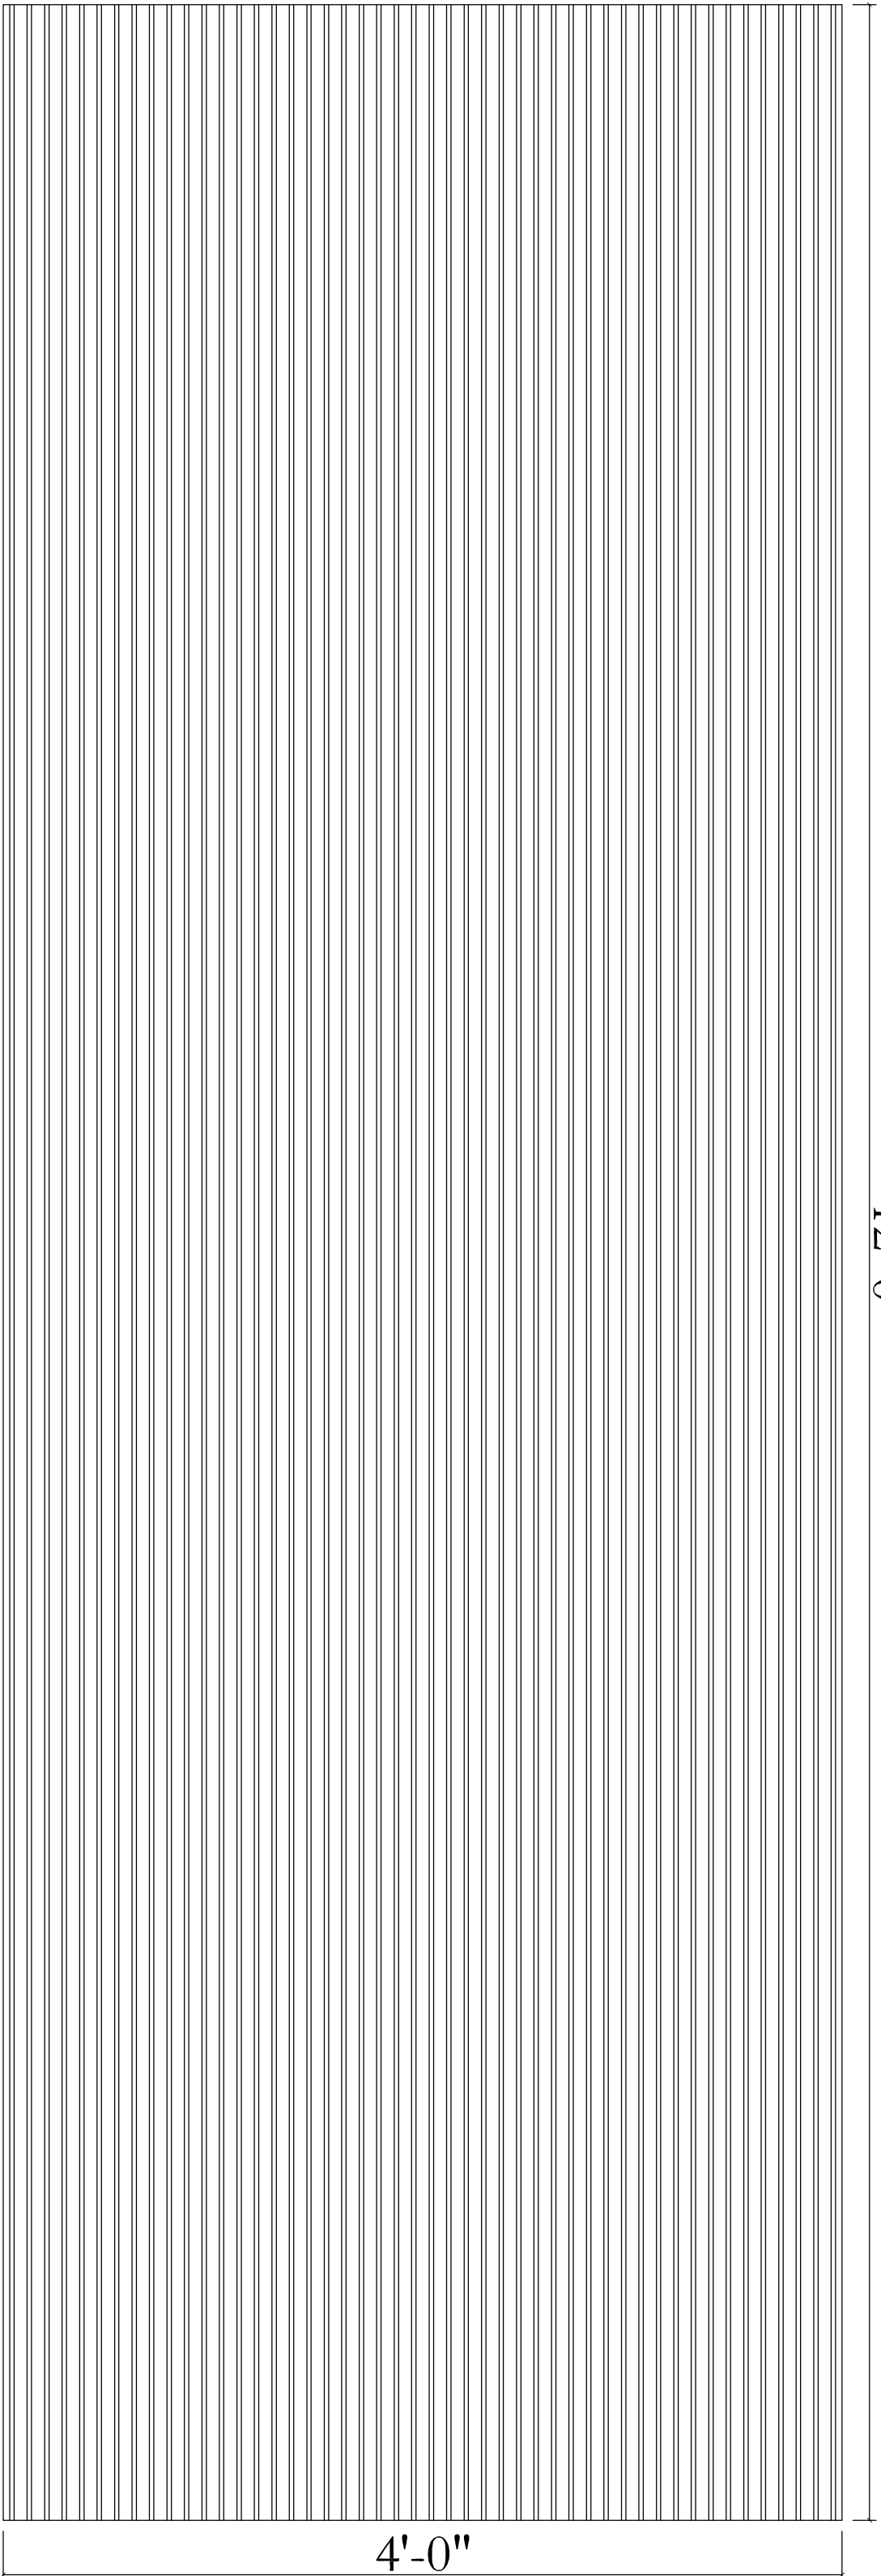
Formliner may require backing provided by customer

12'-0"

Texture not shown for clarity
