damaged formilners caused from improper storage		
Customer:		
Job Name:		
77°.1		
Title:	#898A Rustic Ashlar Assembled

ITEM# 308237 Drawn By: Approved By: Date: Scale: Tolerance:  $\pm 3/16$ None Page: Drawing Number:

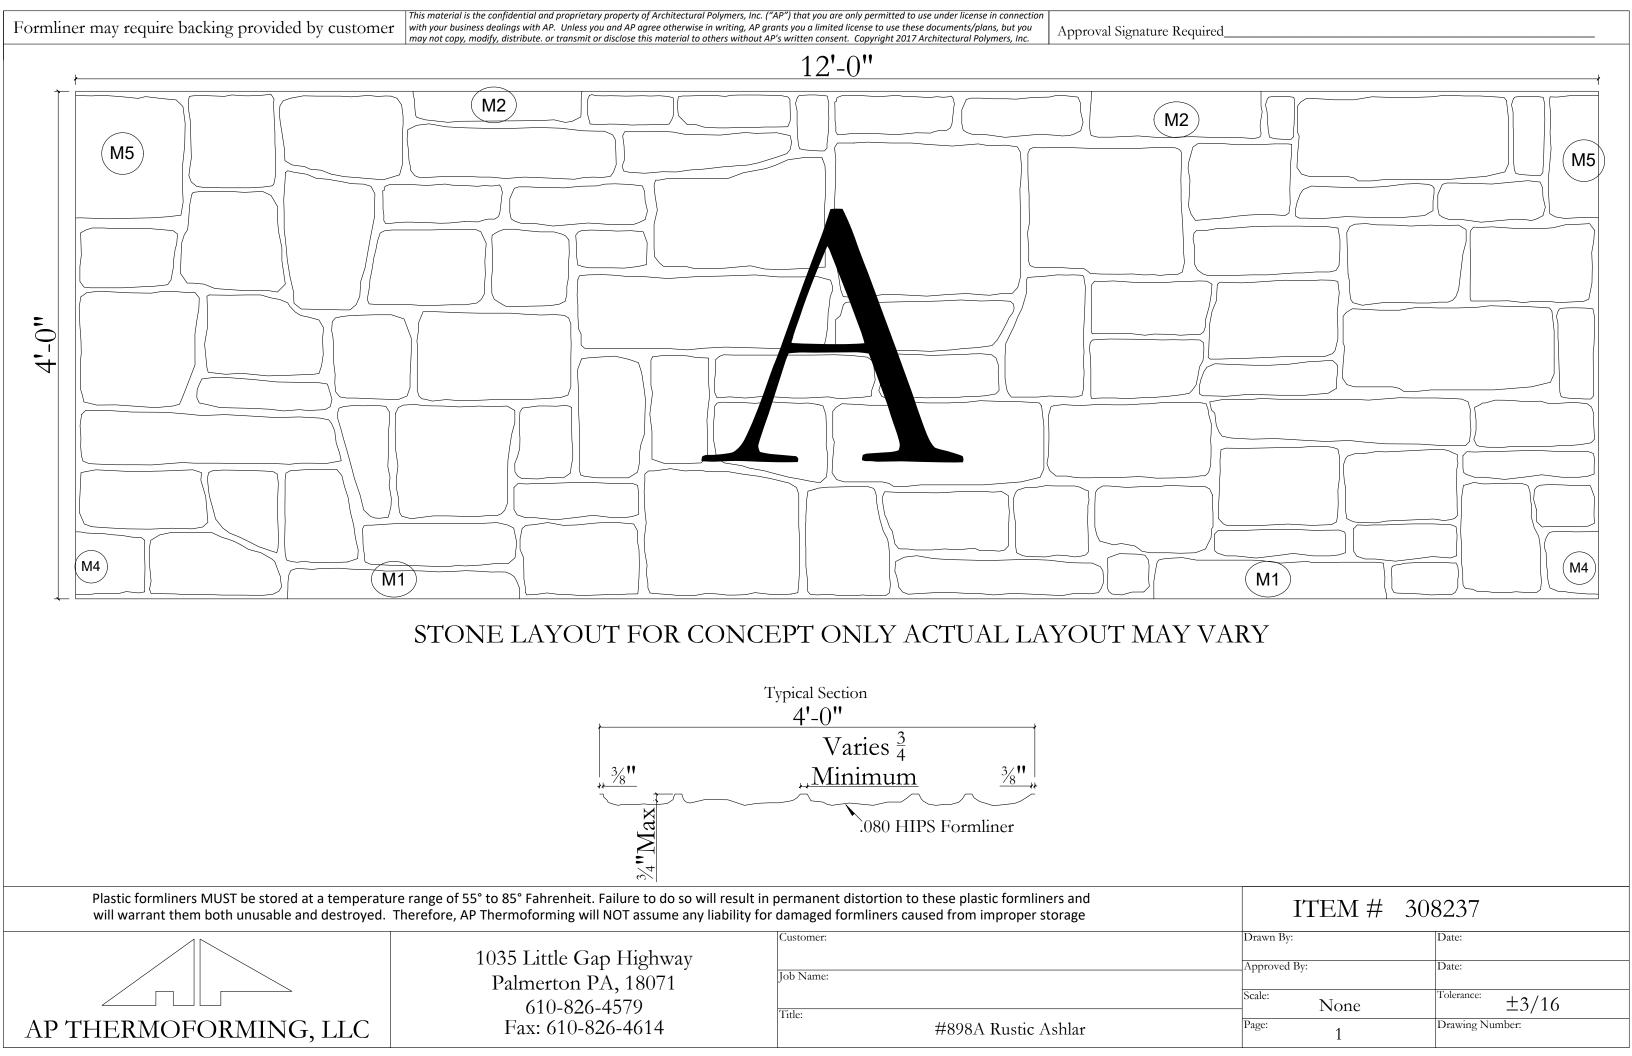
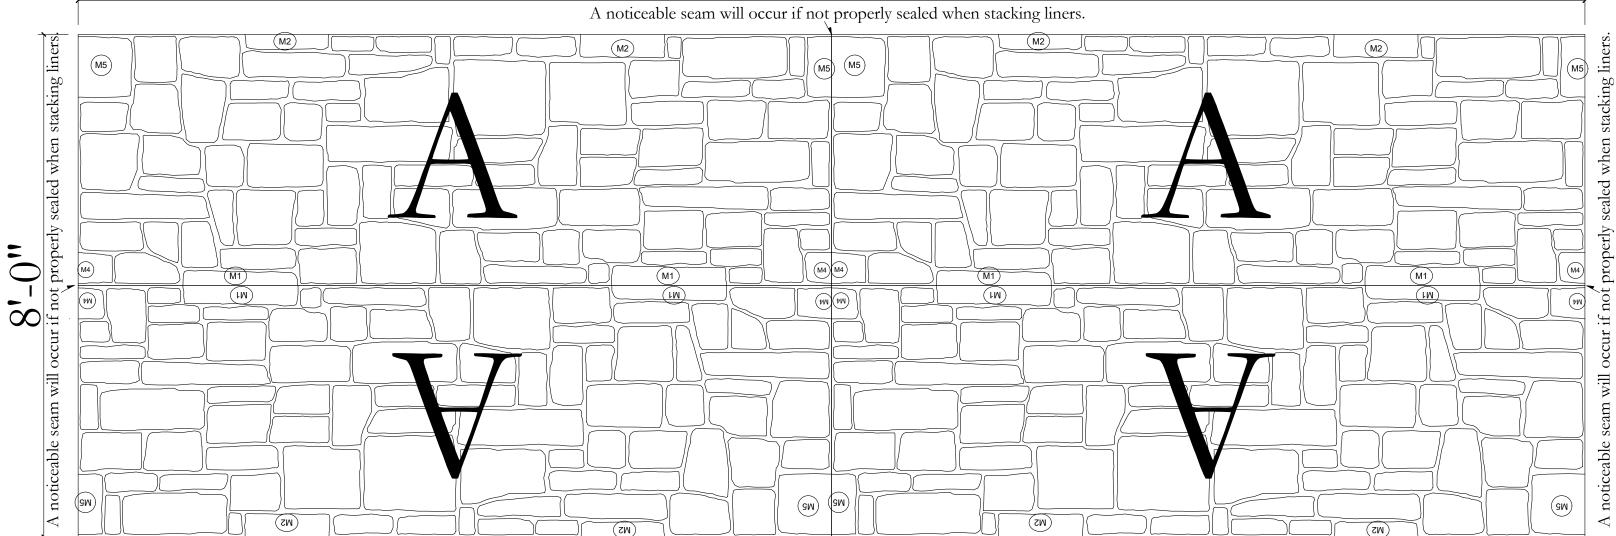
A noticeable seam will occur if not properly sealed when stacking liners.
