.080 HIPS Formliner

Customer:  
 Job Name:  
 Title: #904 Ashlar Stone

Customer:  
 Job Name:  
 Title: #904 Ashlar Stone Assembled

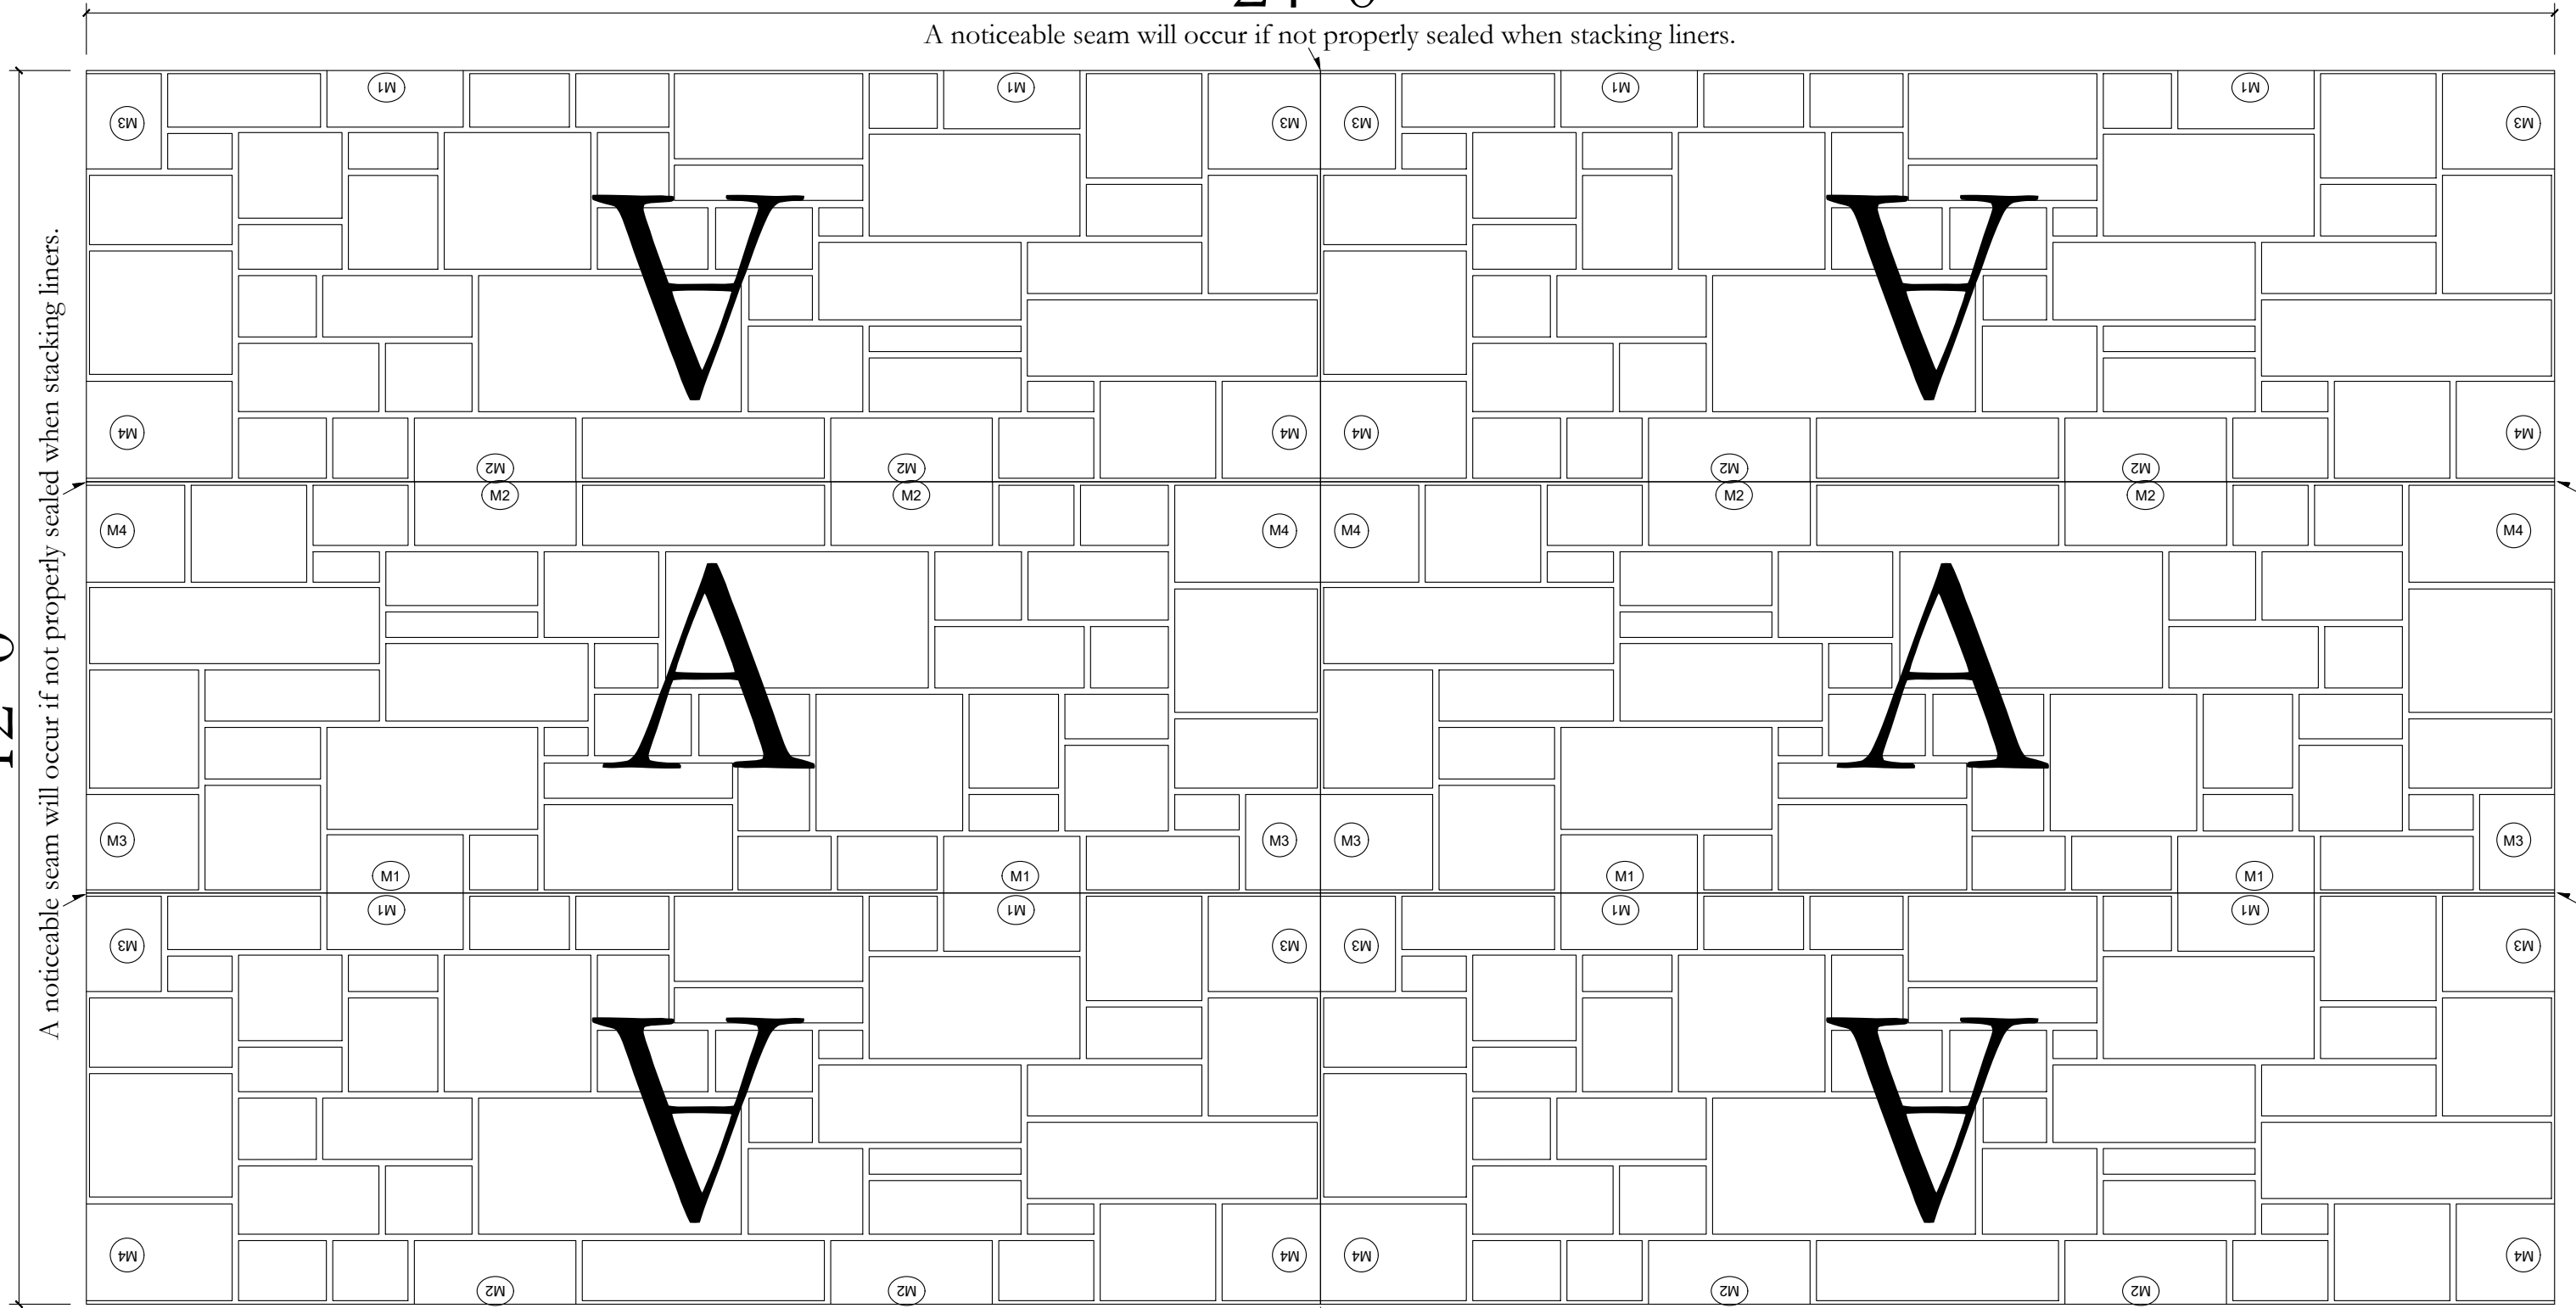
24'-0"

A noticeable seam will occur if not properly sealed when stacking liners.

12'-0"  
A noticeable seam will occur if not properly sealed when stacking liners.
