Customer:
 Job Name:
 Title: #927 Atomic Ashlar

Customer:
 Job Name:
 Title: #927 Atomic Ashlar Assembled

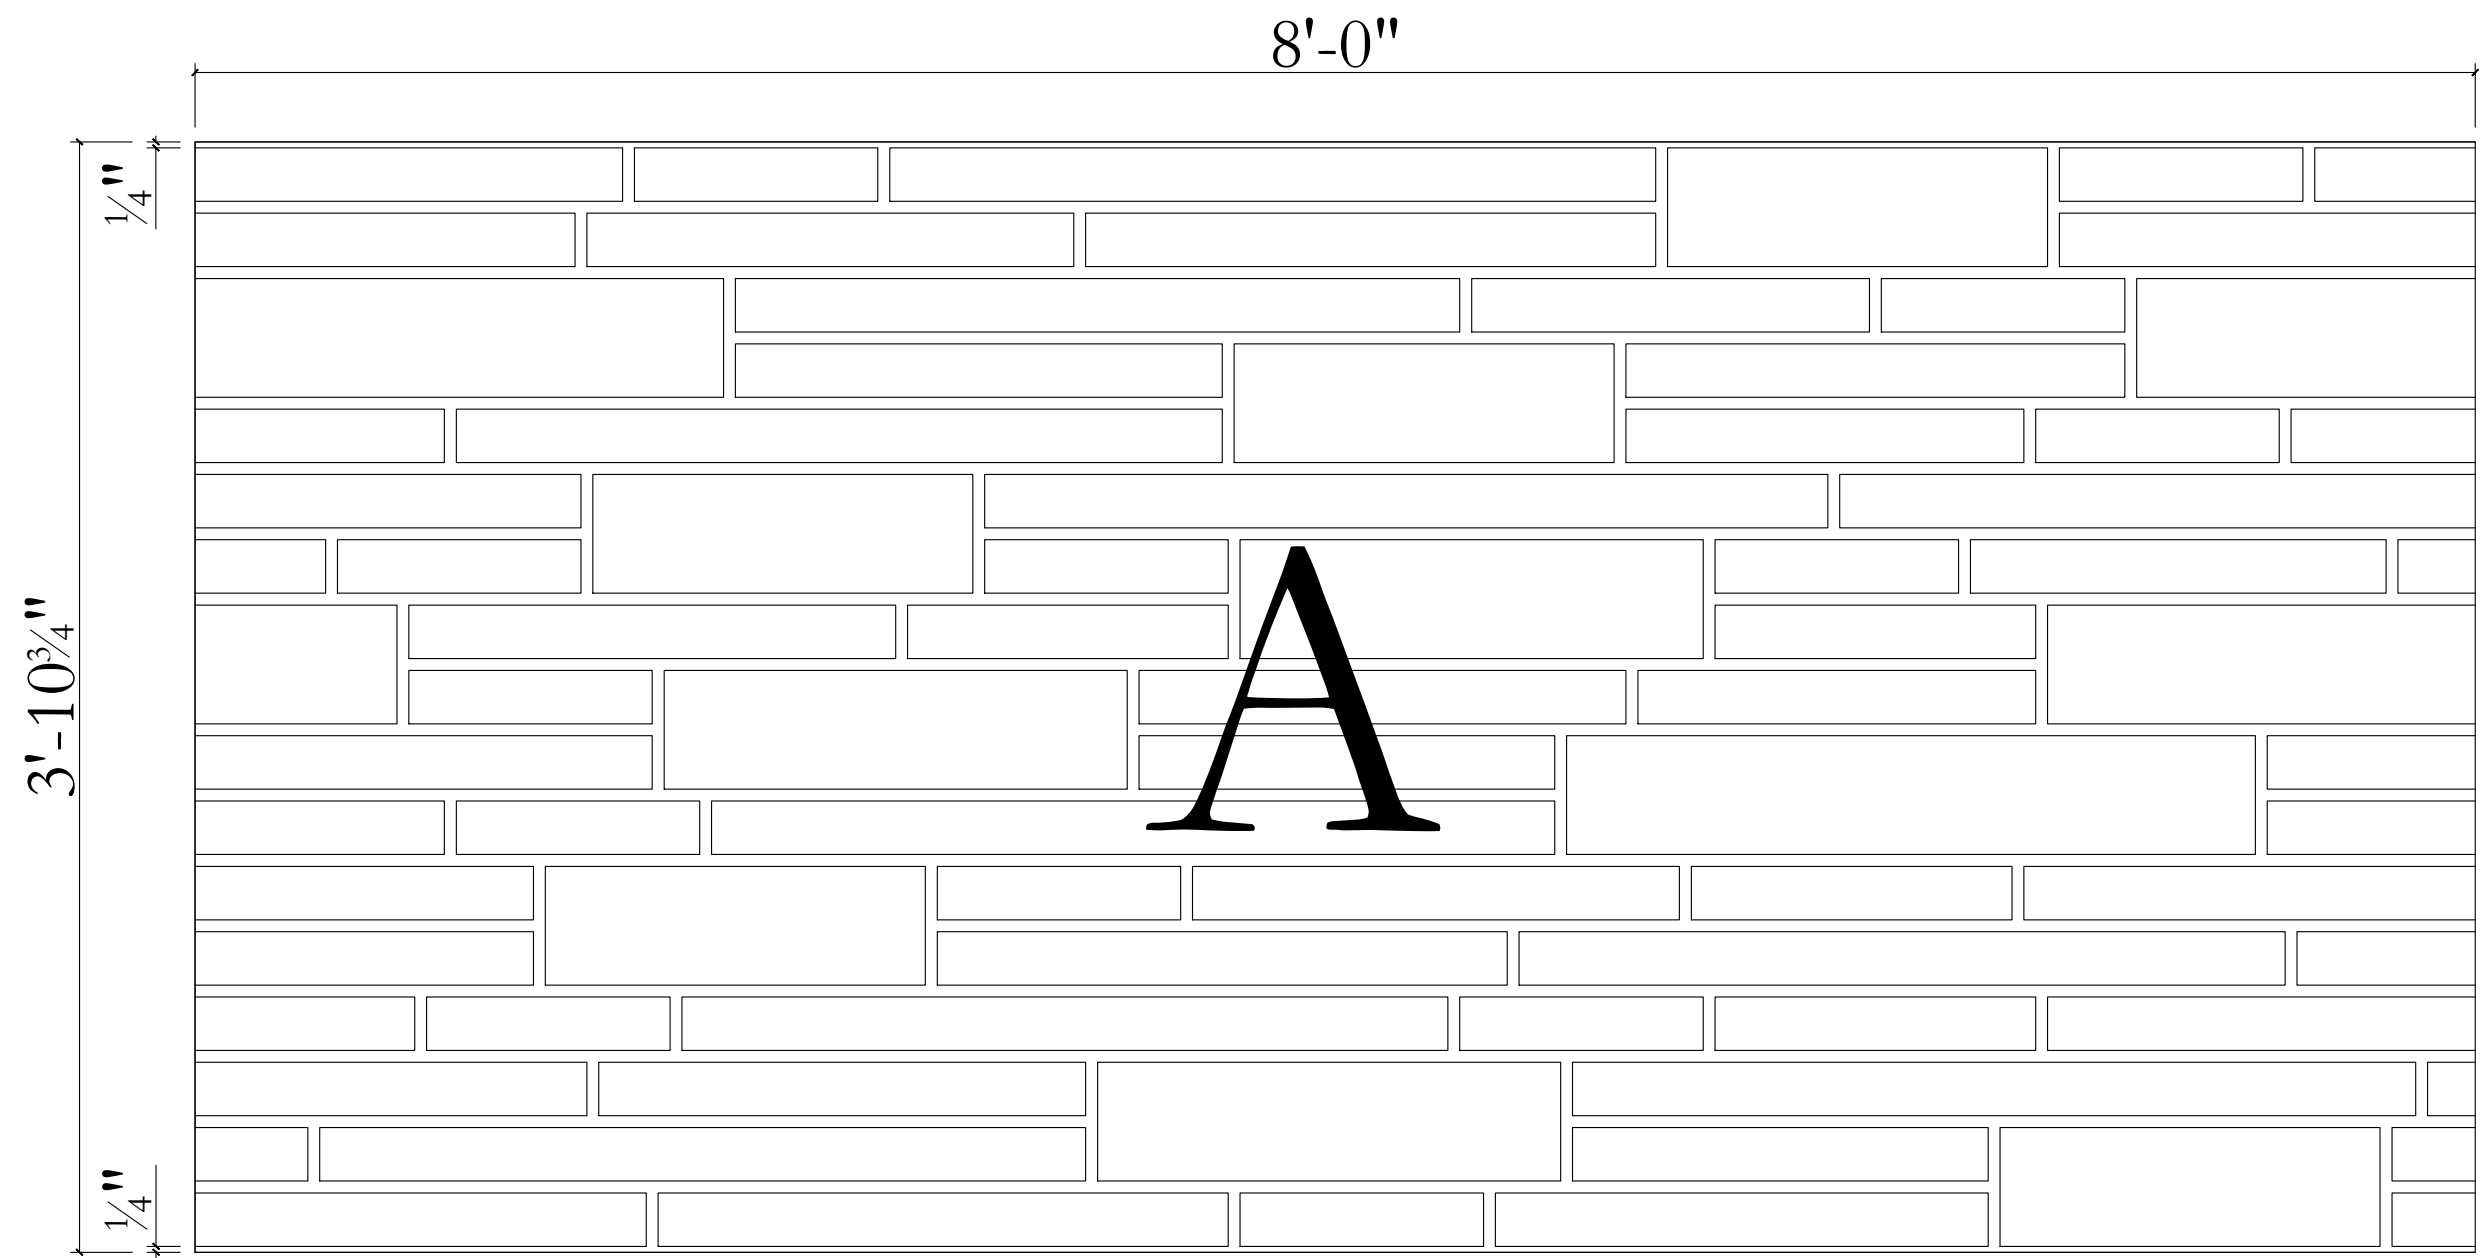
Typical section

↖ .080 HIPS Formliner

16'-0"

7'-9 1/2"

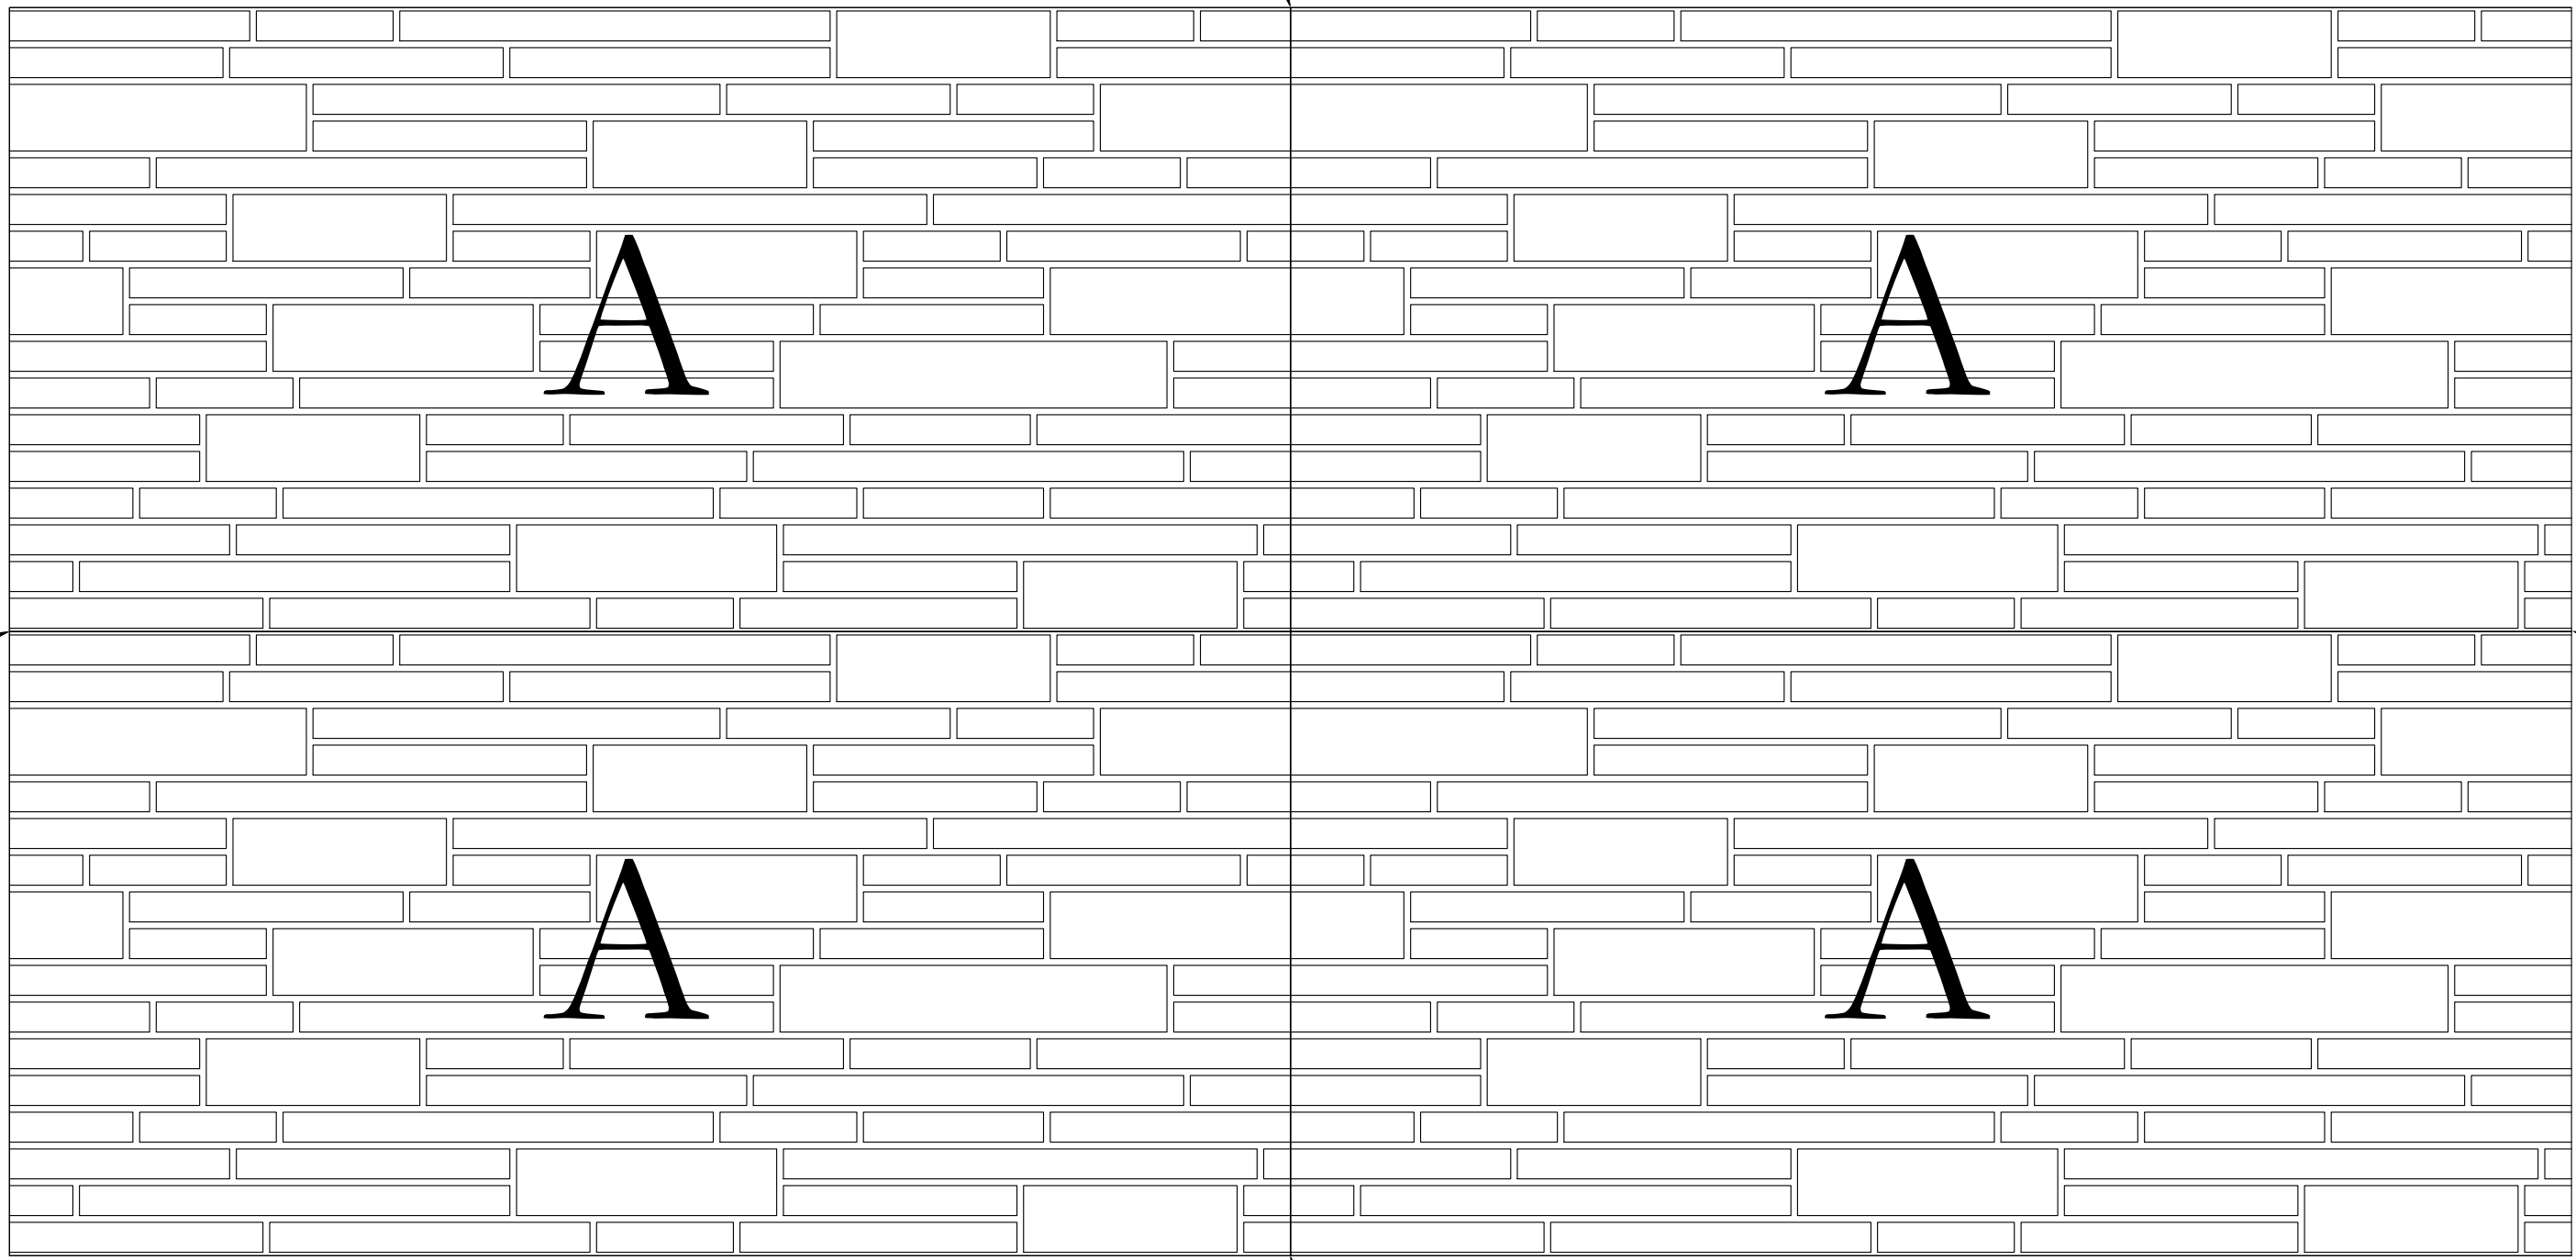
A noticeable seam will occur if not properly sealed when stacking liners.
