ITEM # 304860

Customer:  
Job Name:  
Title: #938 Canal Lock Drystack

#938 Canal Lock Drystack Assembled

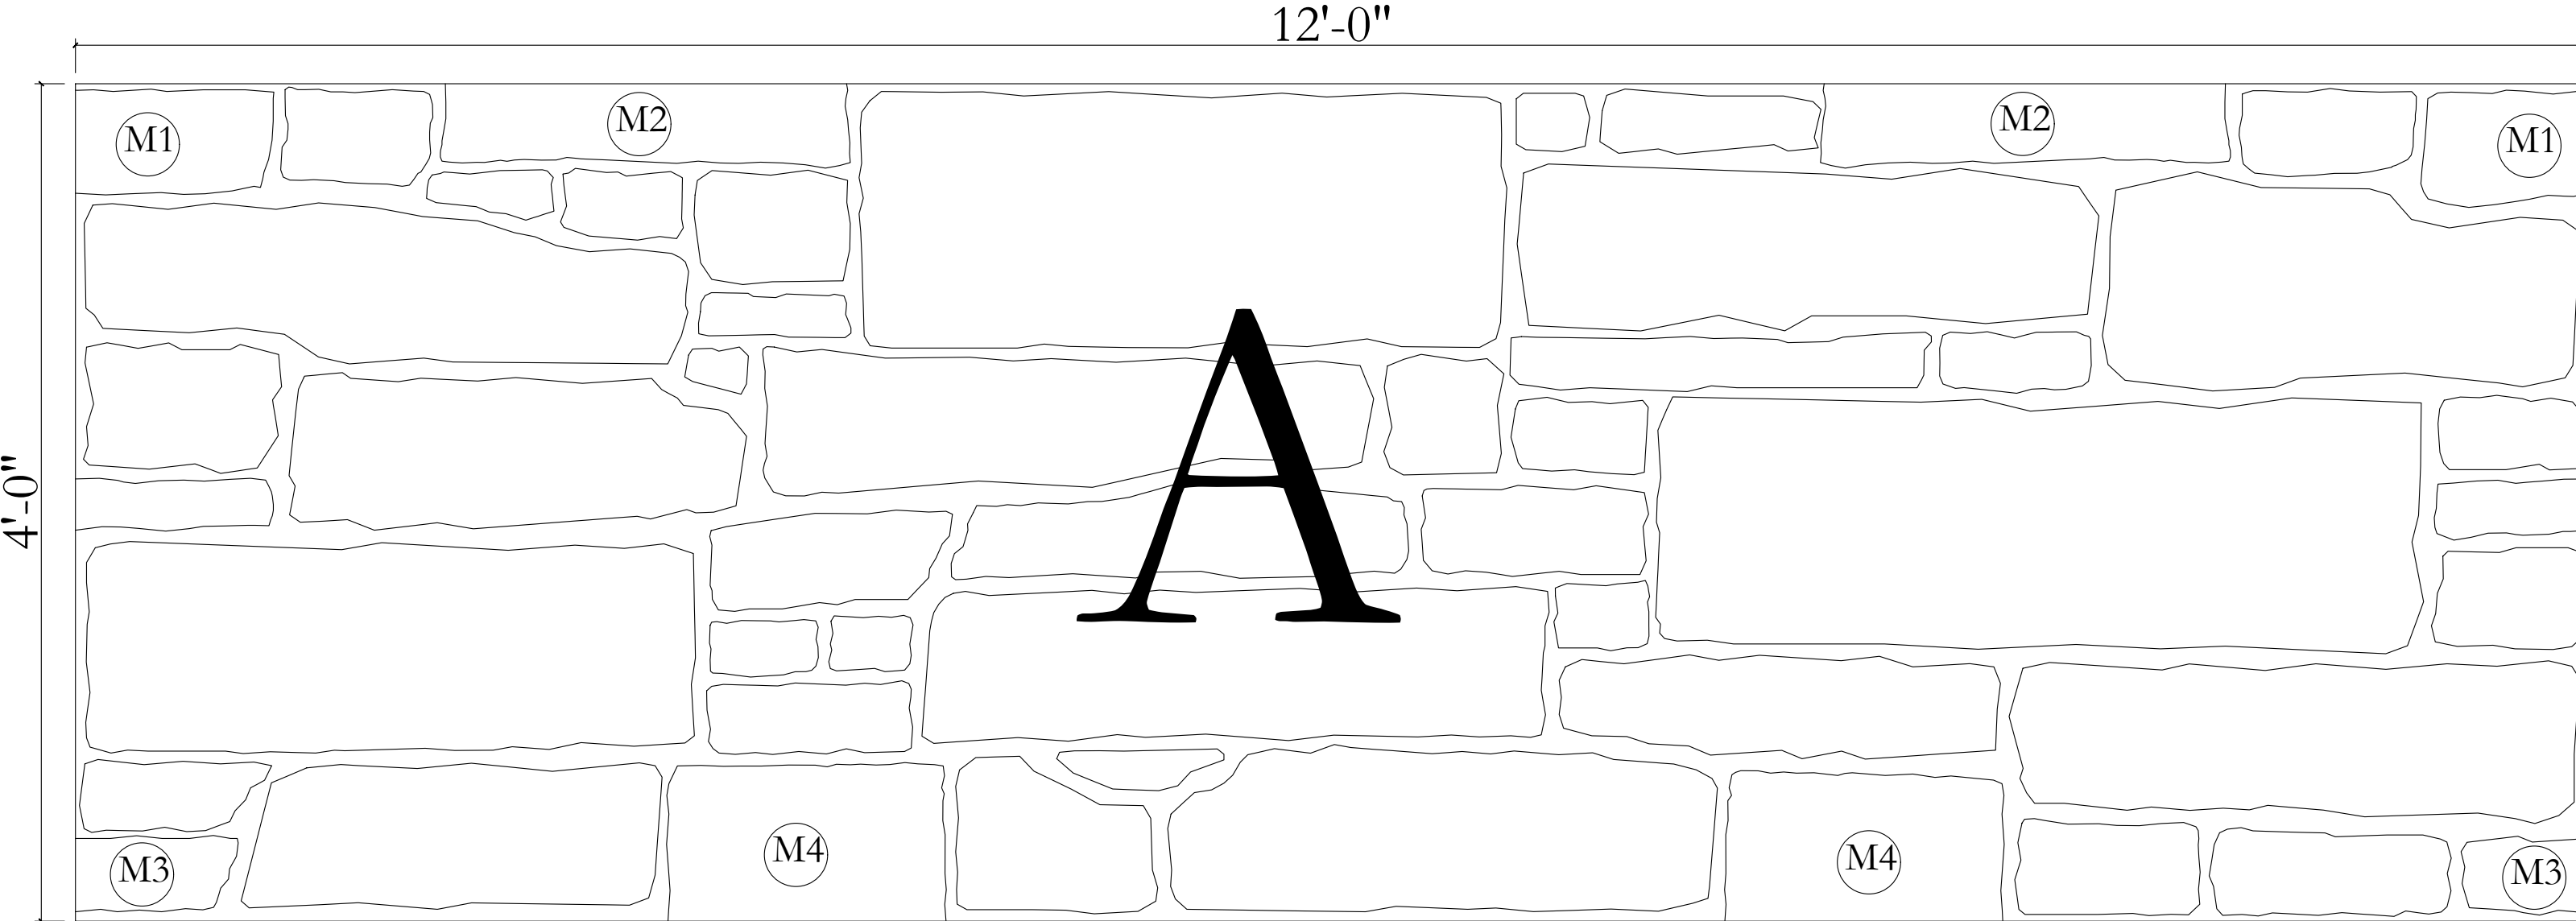
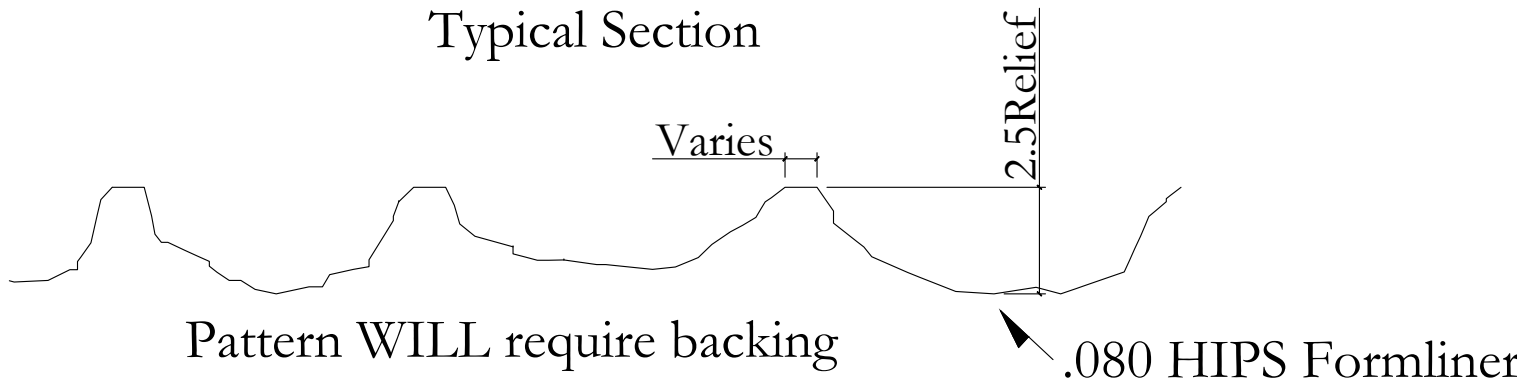
Formliner may require backing provided by customer

Plastic formliners MUST be stored at a temperature range of 55° to 85° Fahrenheit. Failure to do so will result in permanent distortion to these plastic formliners and will warrant them both unusable and destroyed. Therefore, AP Thermoforming will NOT assume any liability for damaged formliners caused from improper storage
