Customer:
Job Name:
Title: #313 Salem Staggered Type A

Customer:
Job Name:
Title: #313 Salem Staggered Type B

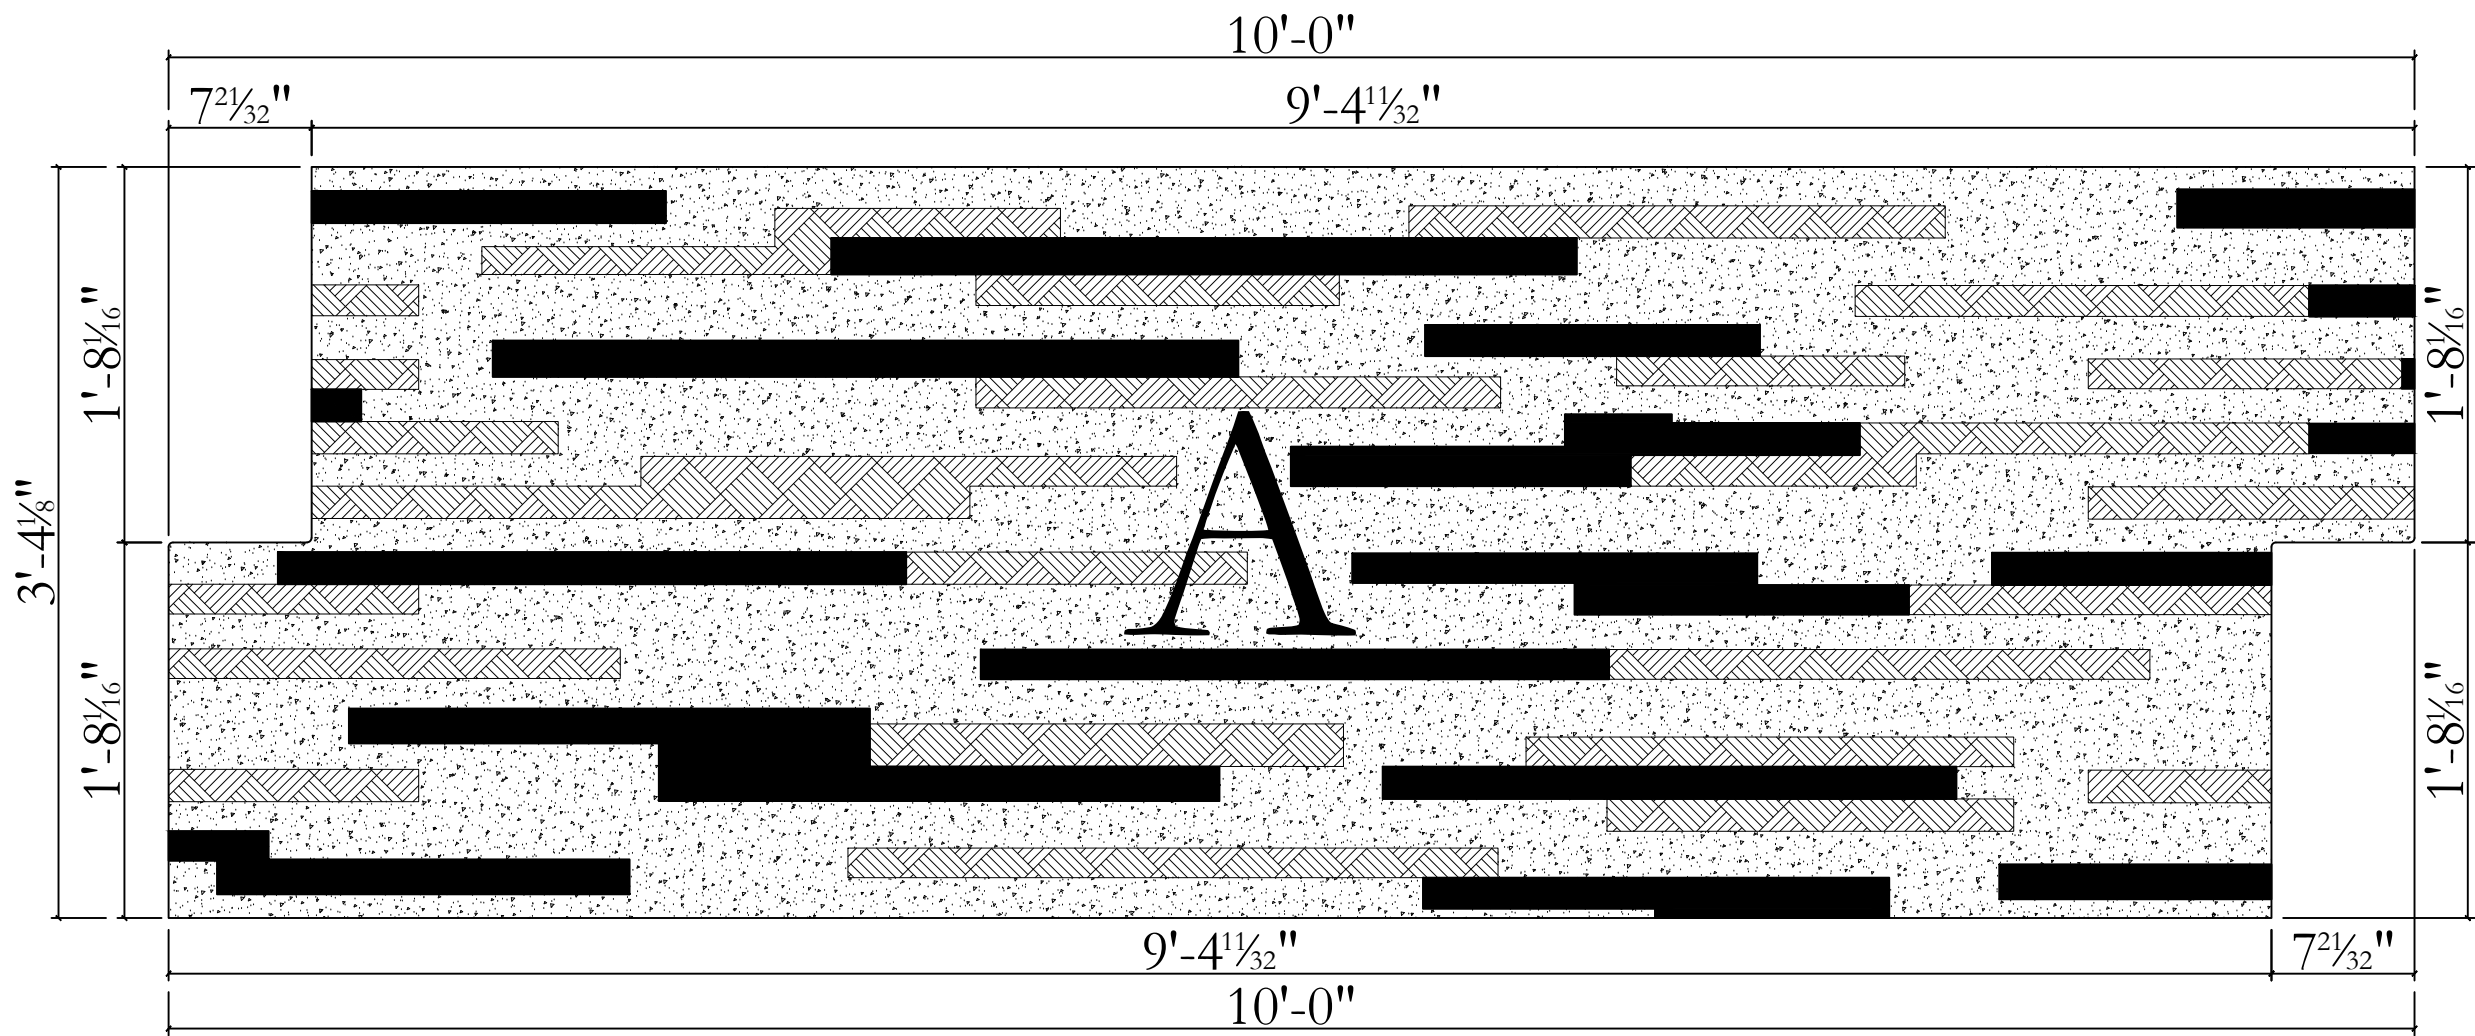
- +0" Concrete
- +1/4" Concrete
- +1/2" Concrete

Actual Pattern May Vary

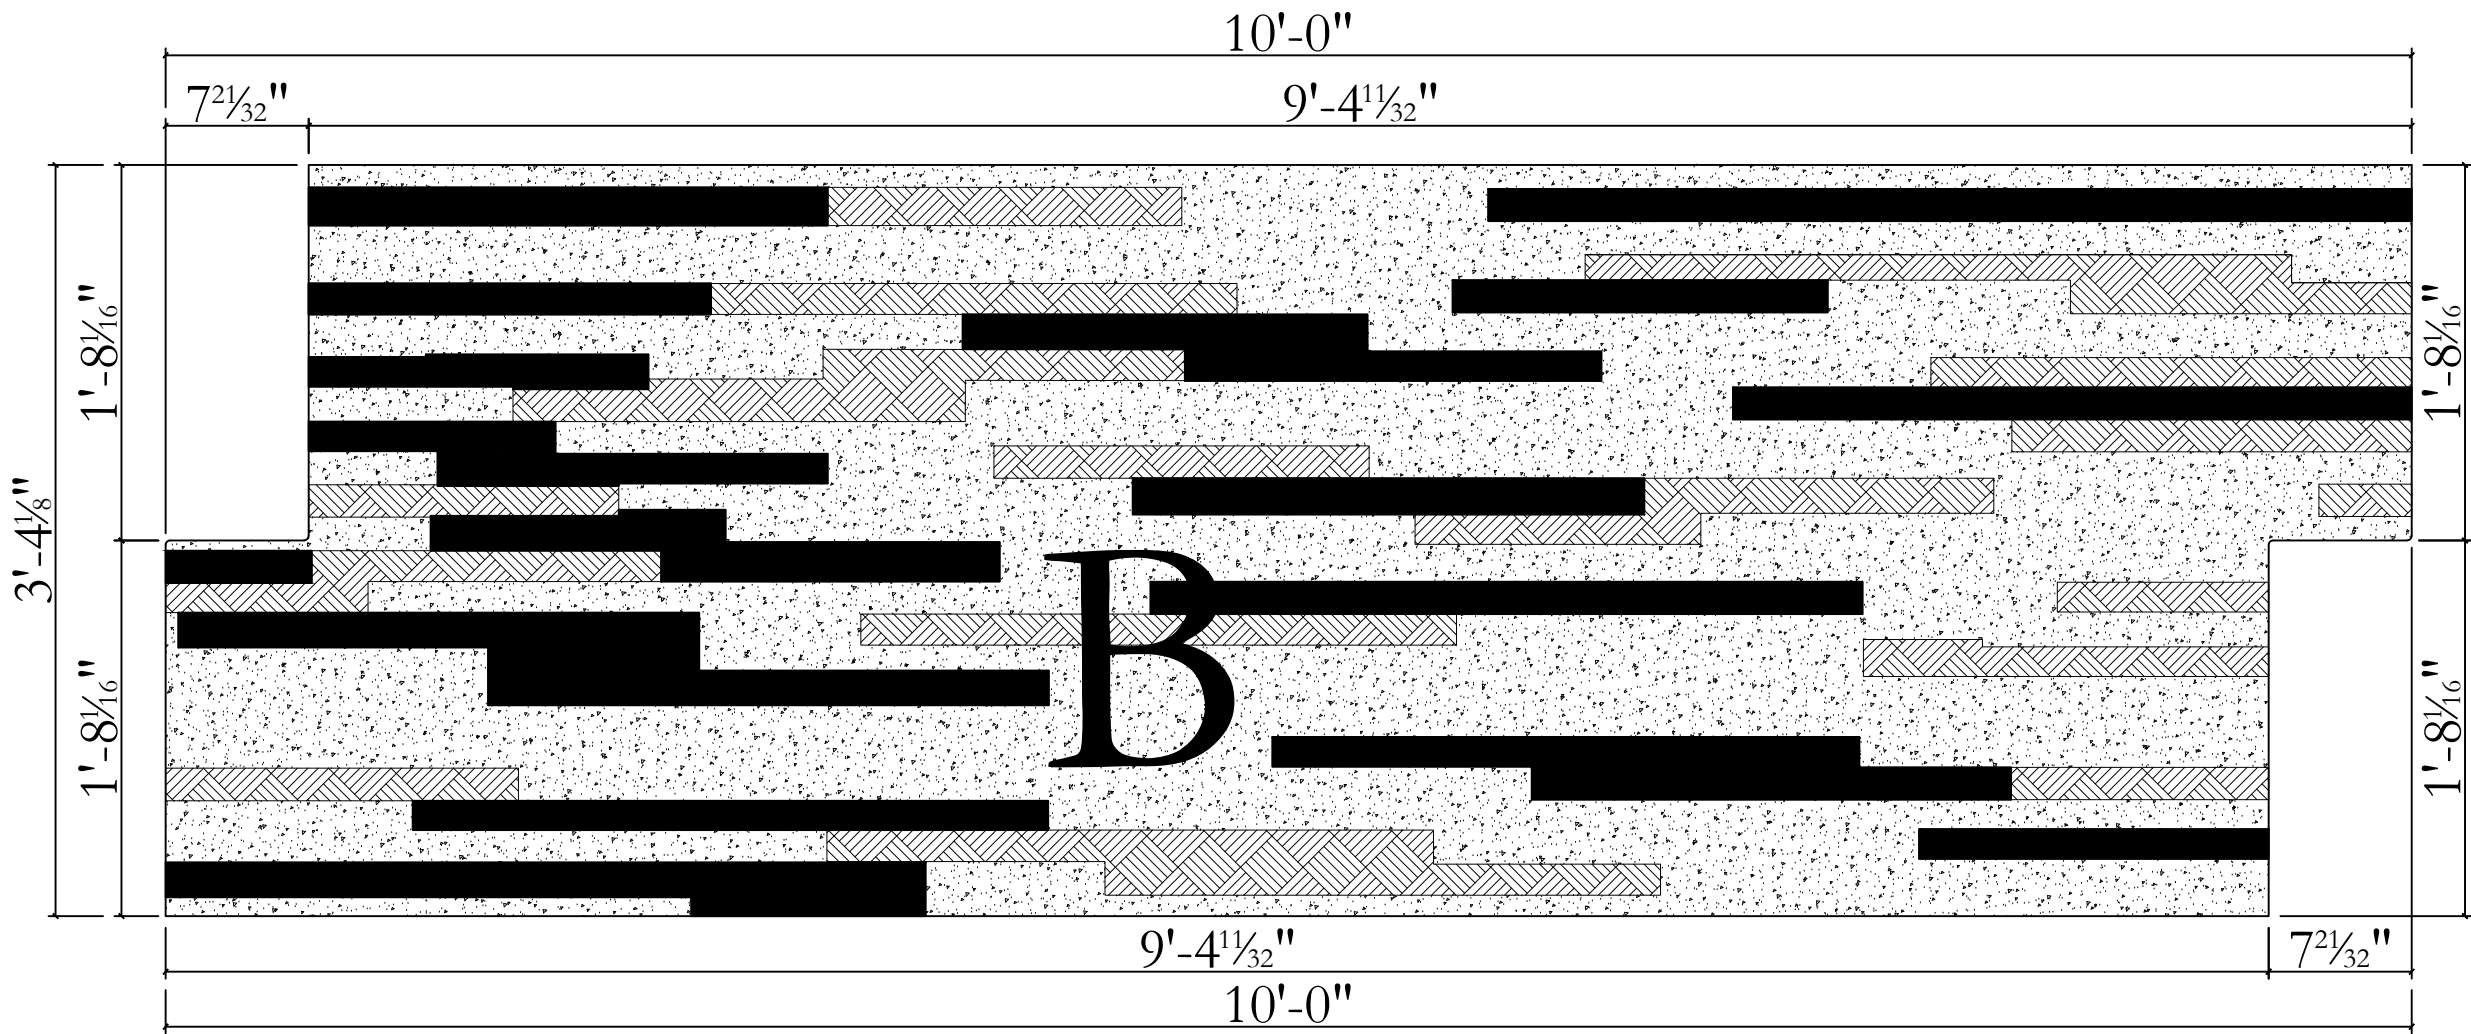
- +0" Concrete
- +1/4" Concrete
- +1/2" Concrete

Actual Pattern May Vary
