Customer:  
 Job Name:  
 Title: #892B 12in Quarry Stone Type 1

Customer:  
 Job Name:  
 Title: #892B 12in Quarry Stone Type 1 Assembled

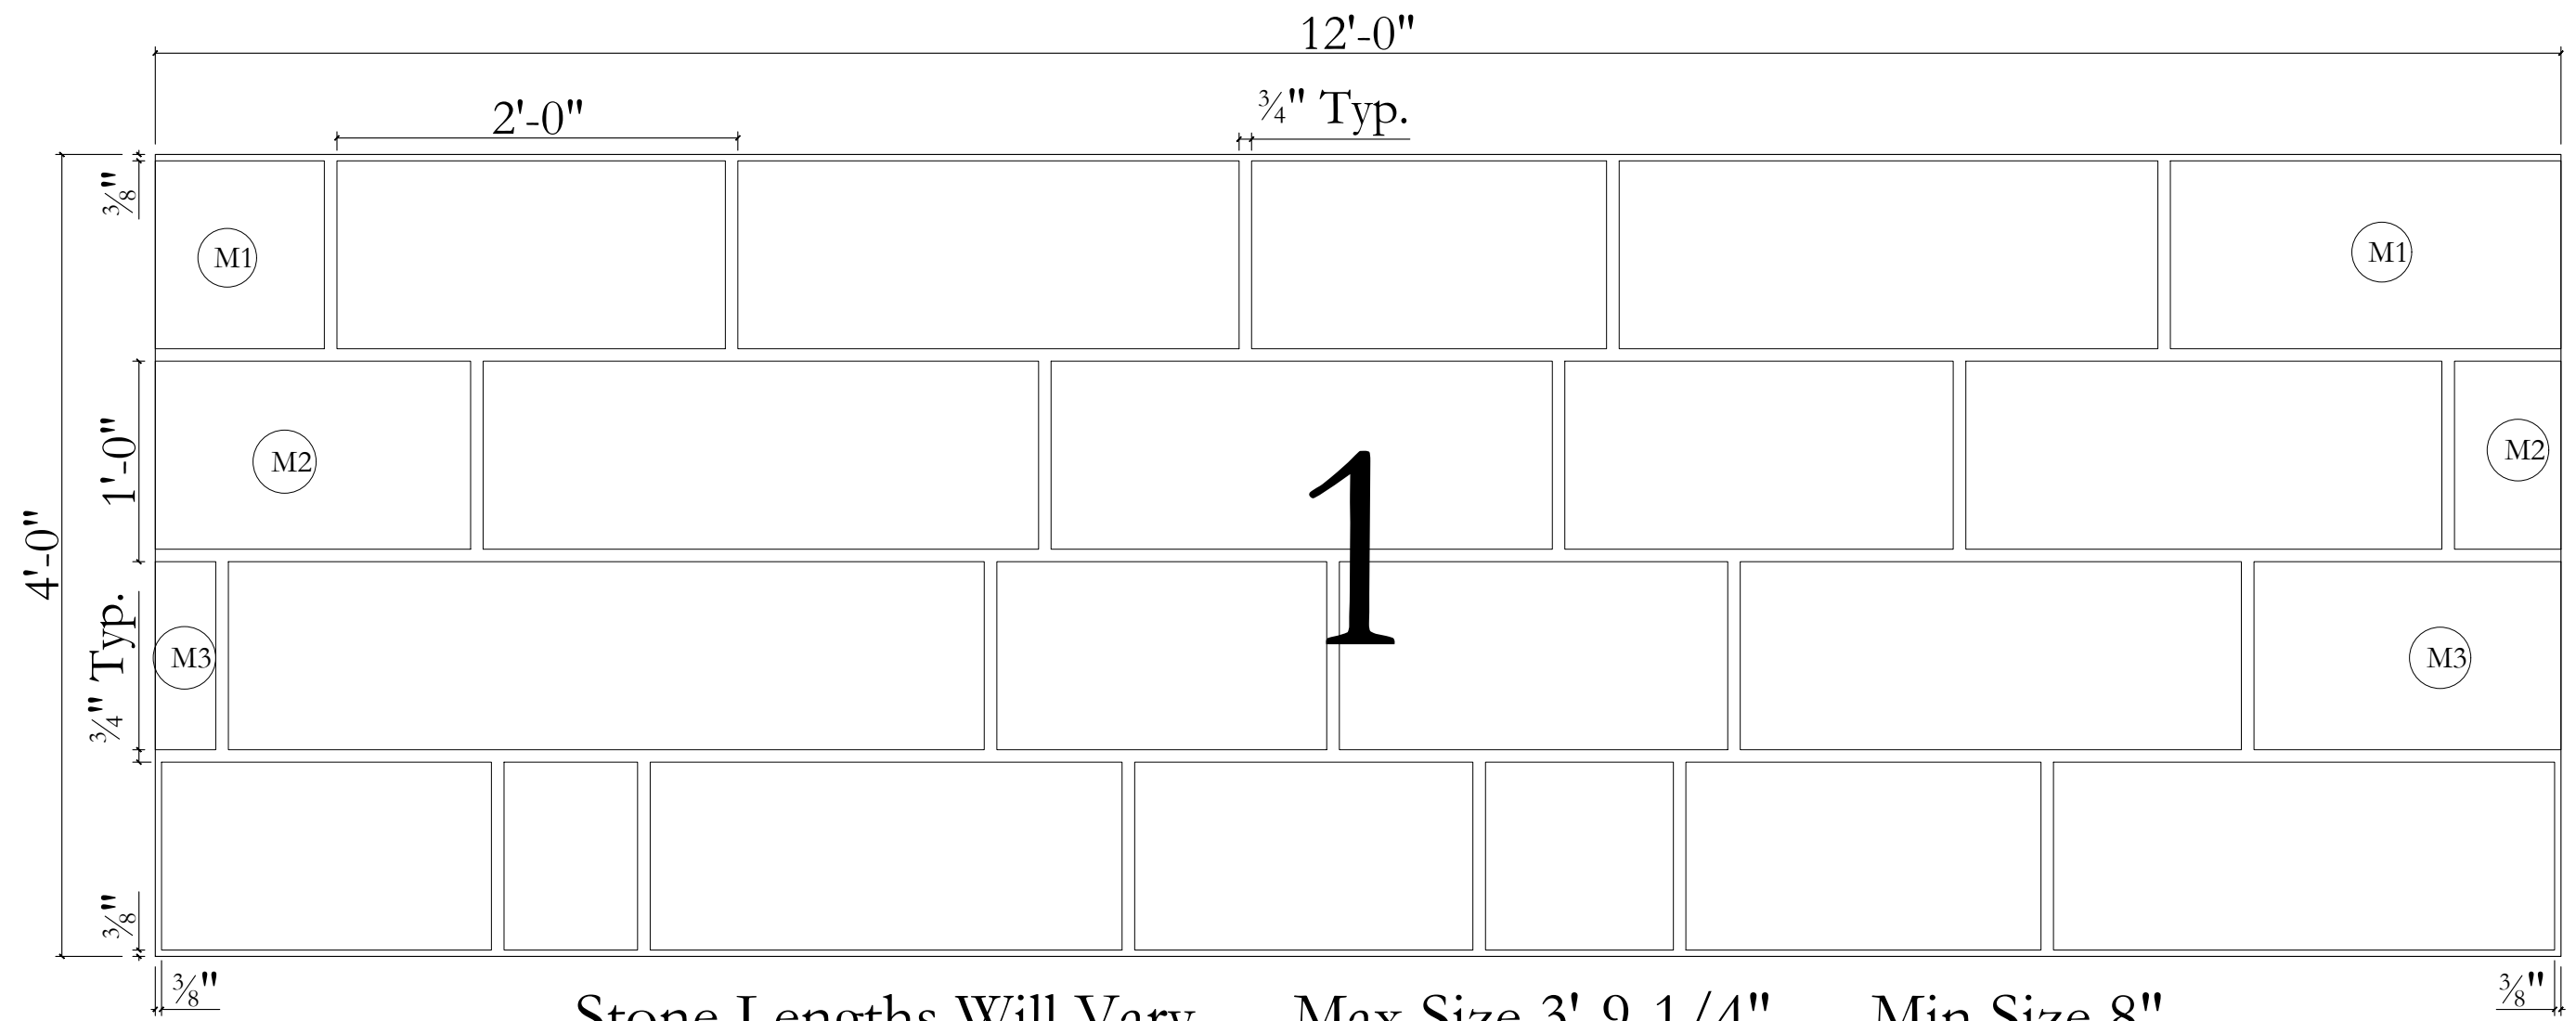
Stone Lengths Will Vary\_\_\_Max Size 3'-9-1/4"\_\_\_Min Size 8"  
 Actual Stone Layout to be determined by AP

Ⓜ = Match Stone

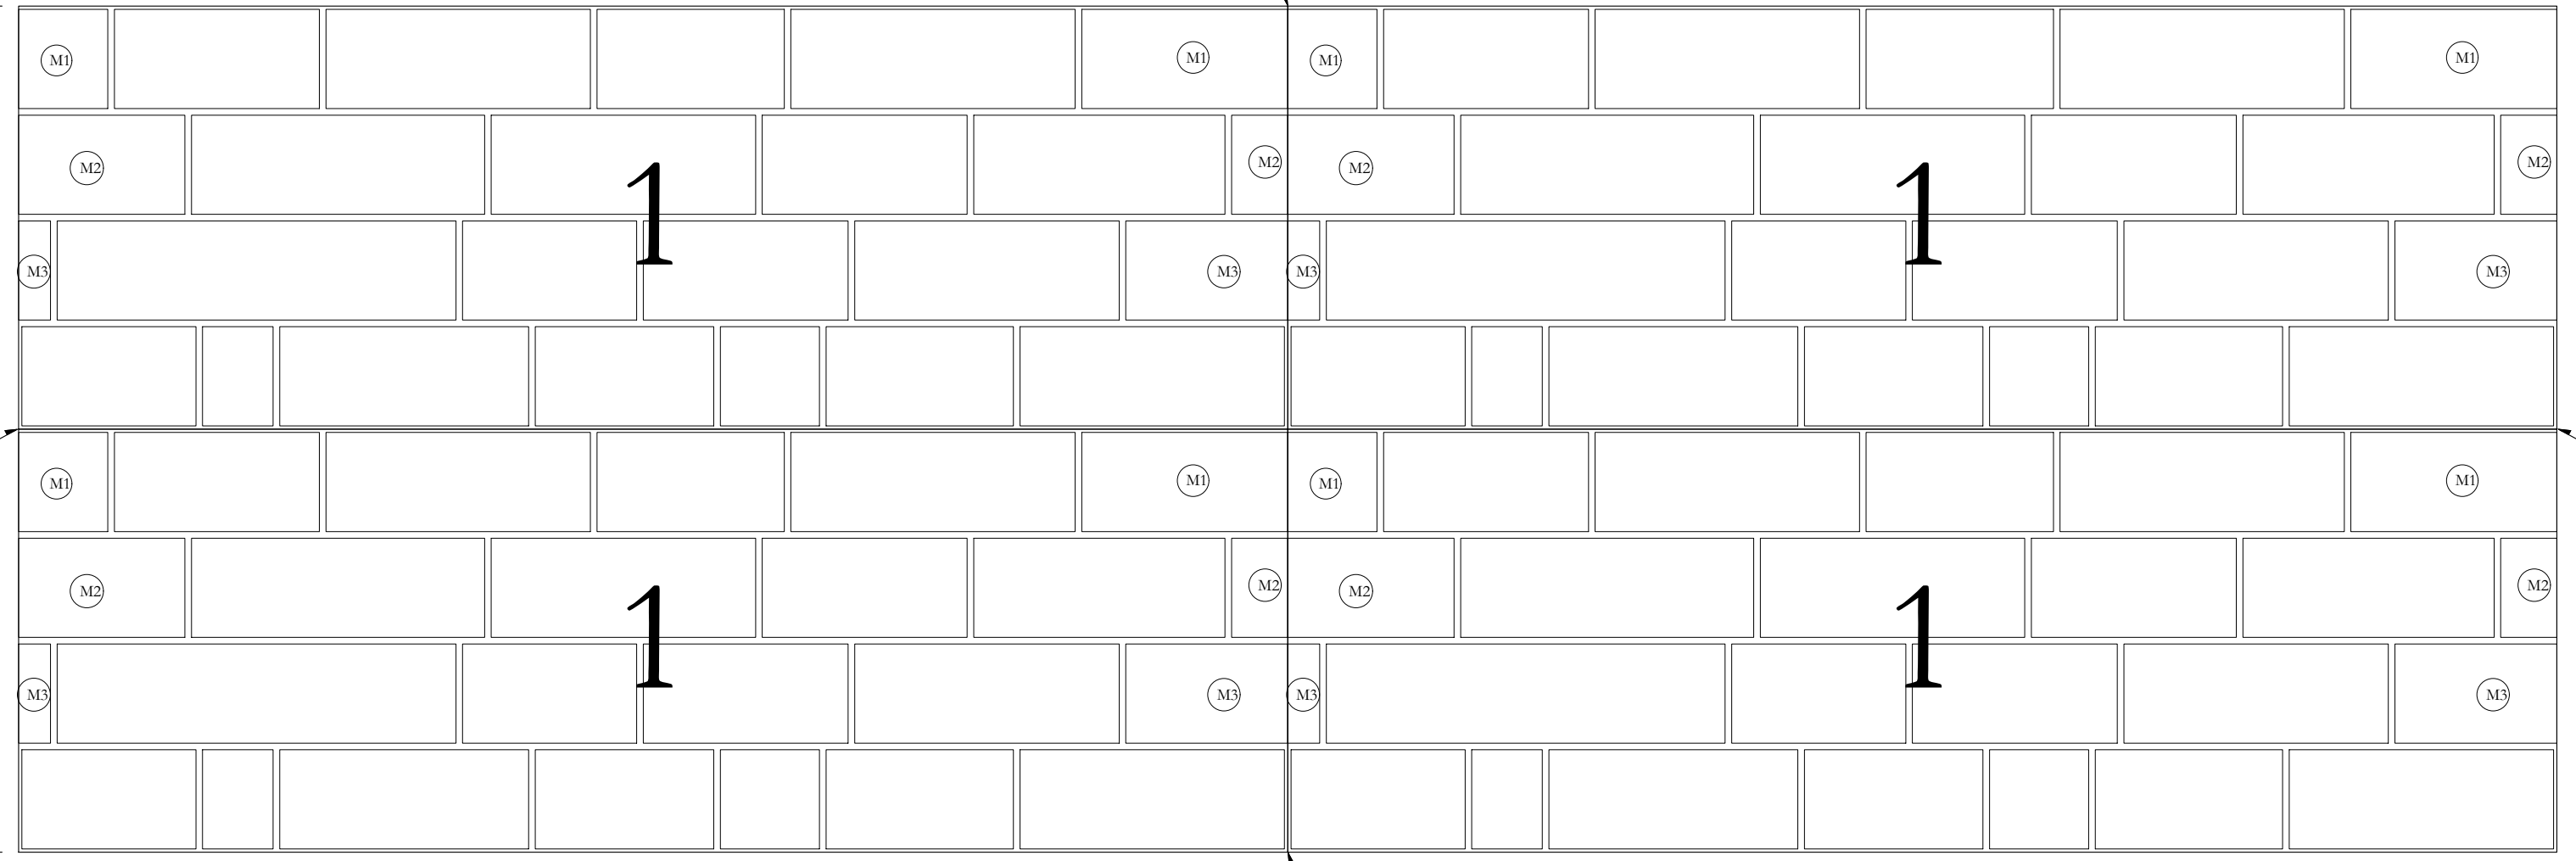
24'-0"

A noticeable seam will occur if not properly sealed when stacking liners.

8'-0"  
A noticeable seam will occur if not properly sealed when stacking liners.
