ITEM # 305282

Customer:
 Job Name:
 Title: #943 3/4 Drystack

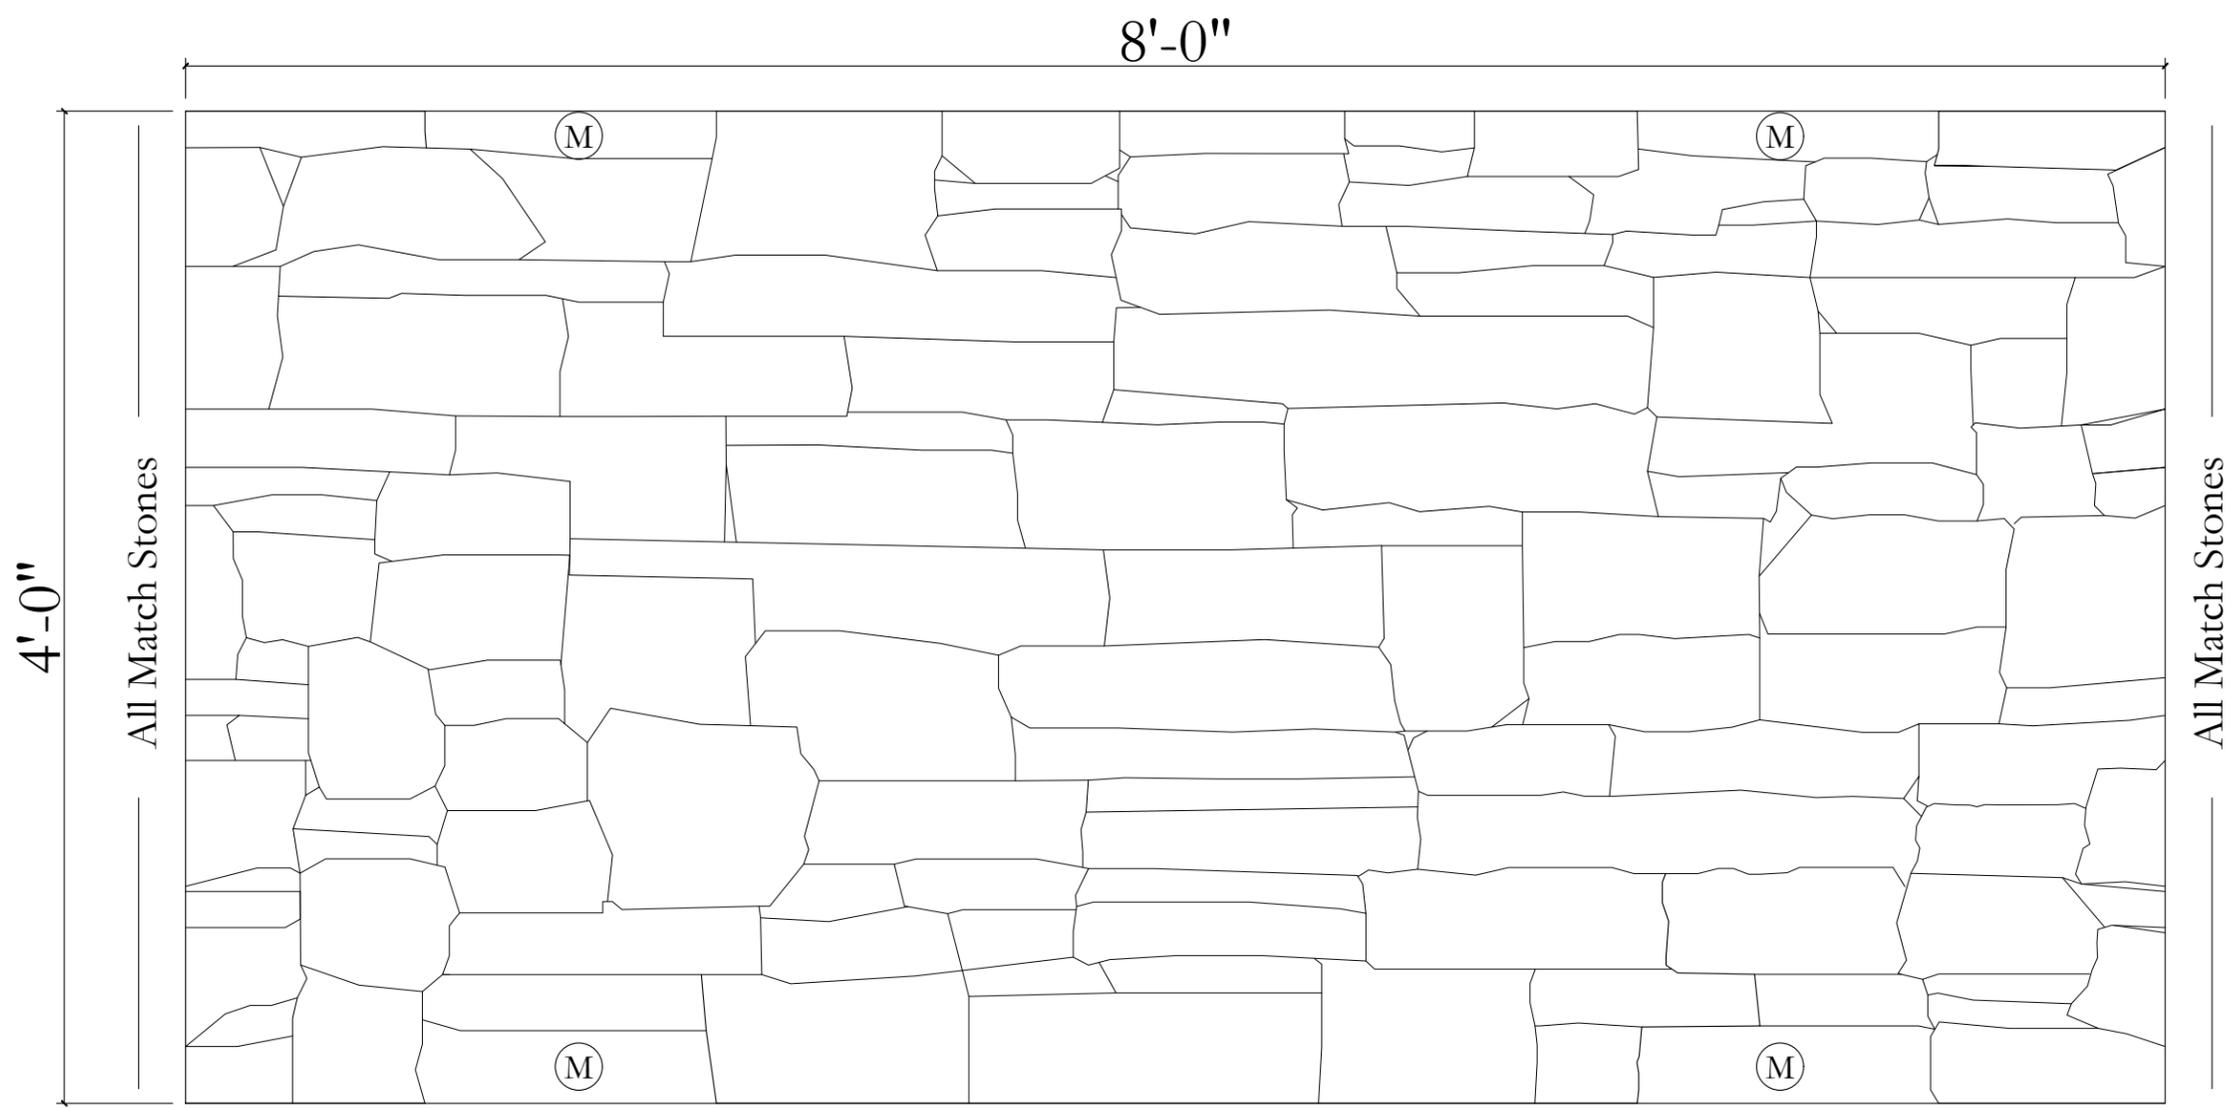
Actual Stone Layout Will Vary

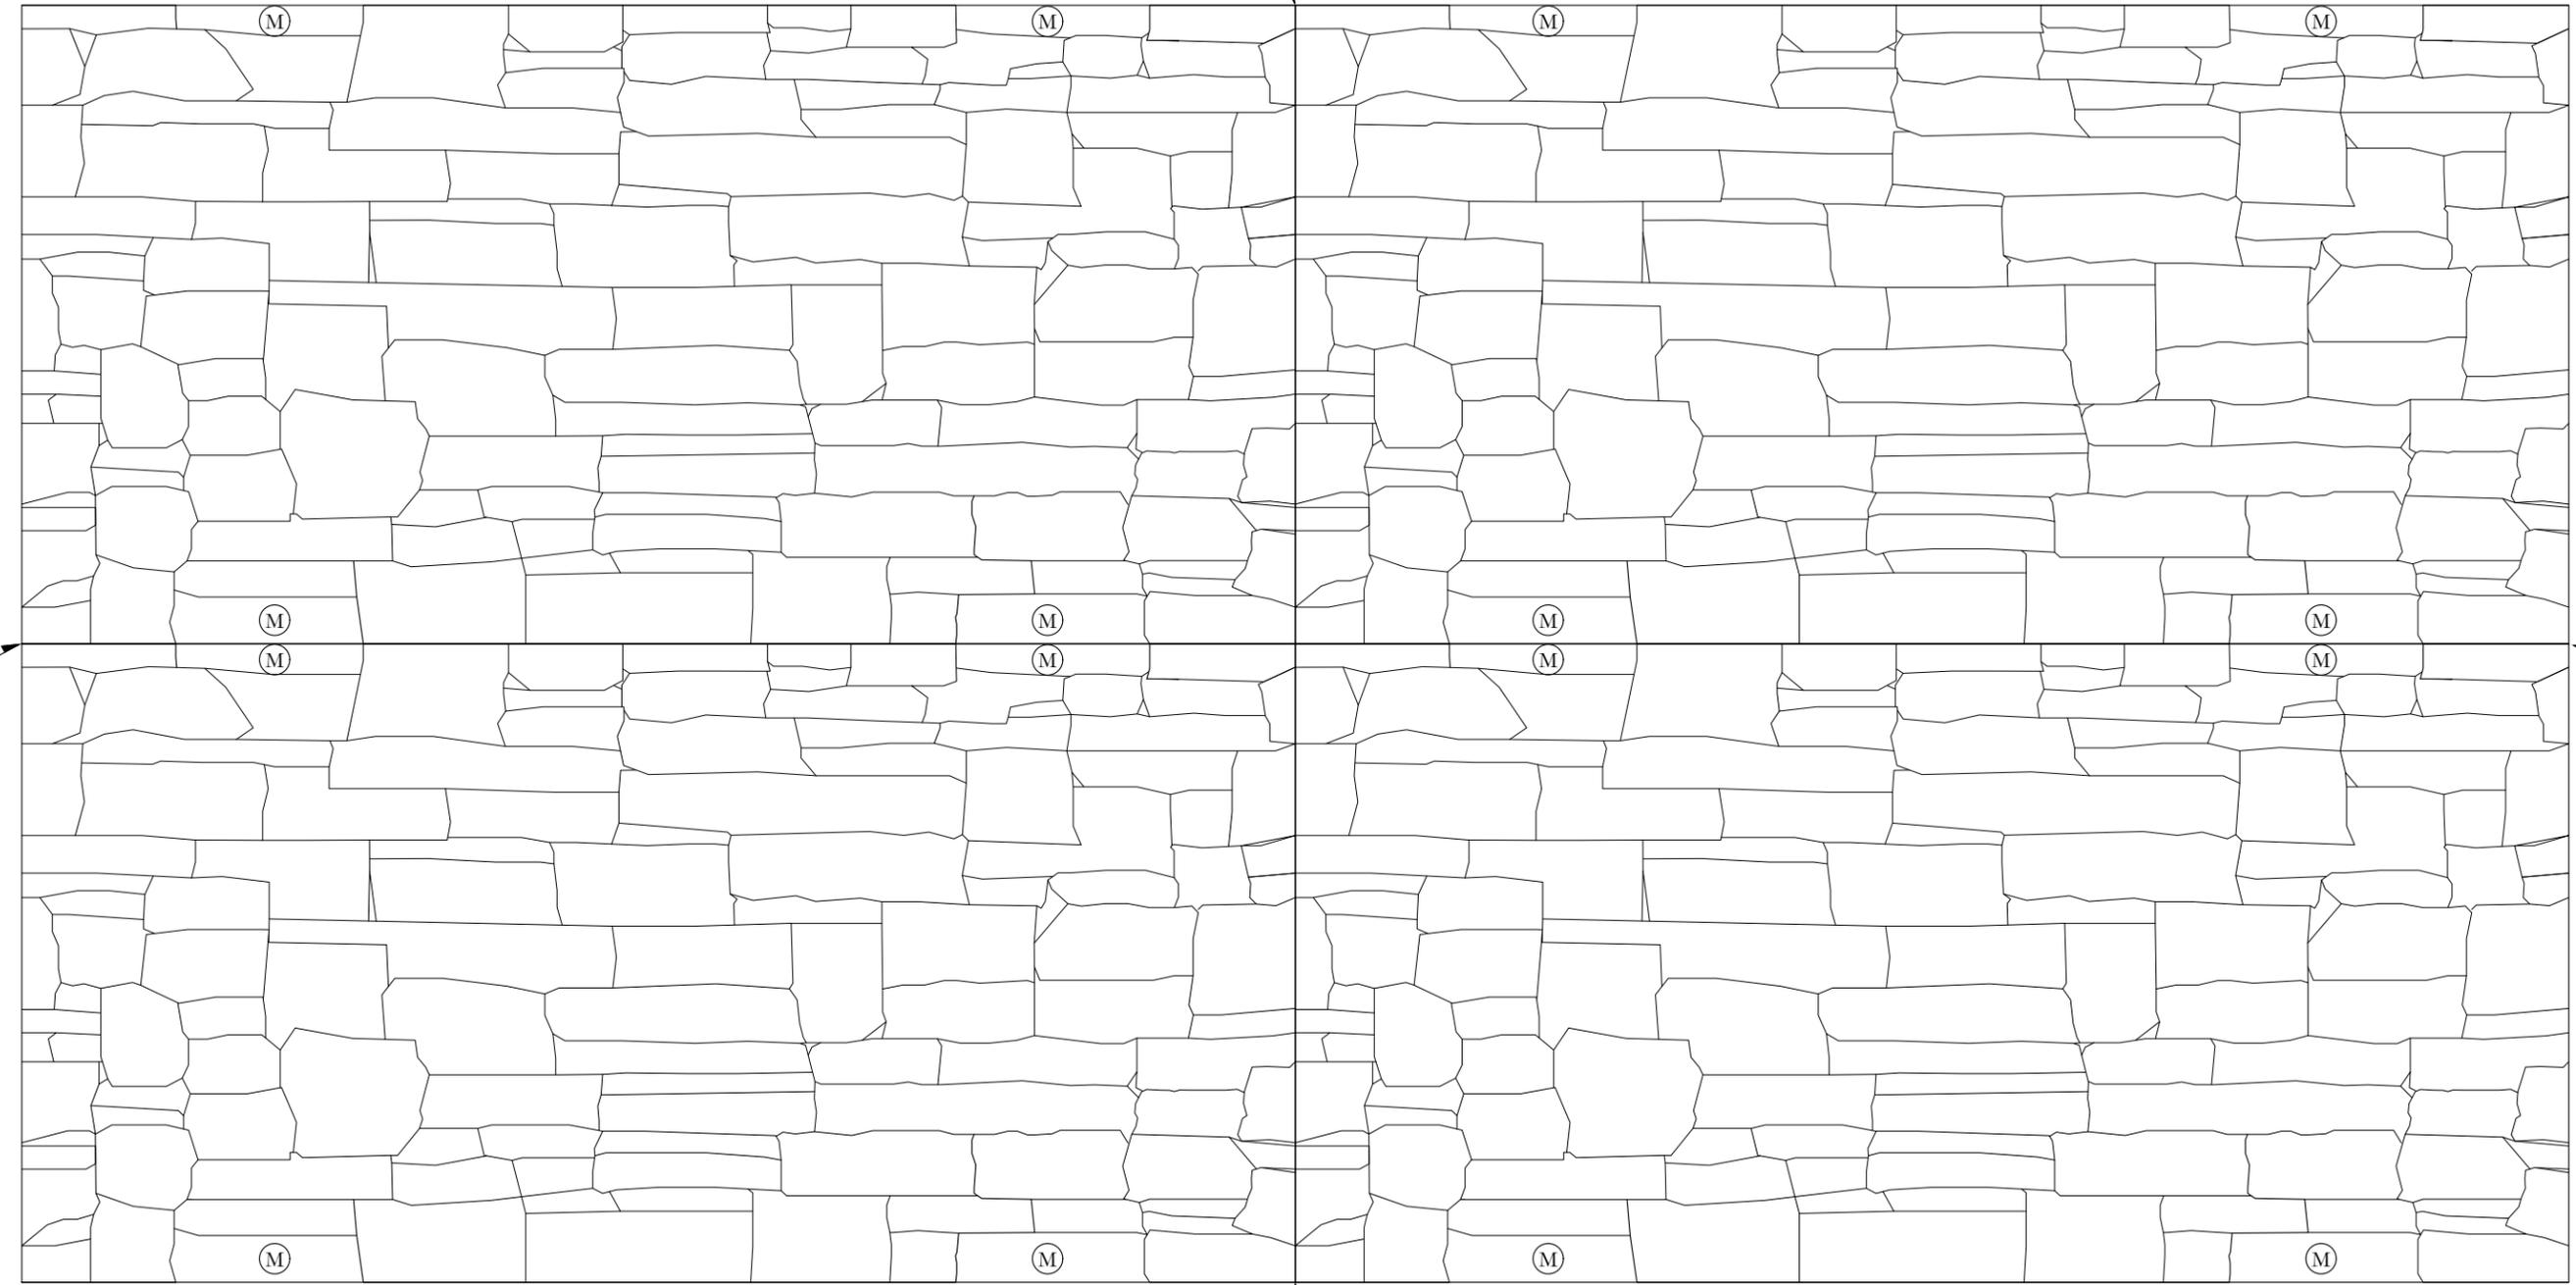
16'-0"

A noticeable seam will occur if not properly sealed when stacking liners.

8'-0"
