Customer:		Drawn By:		Date:	
Job Name:		Approved By:		Date:	
Title:	#946 Southern Drystack	Scale:	None	Tolerance:	±3/16
		Page:	1	Drawing Number:

Customer:	
Job Name:	
Title:	#946 Southern Drystack Assembled

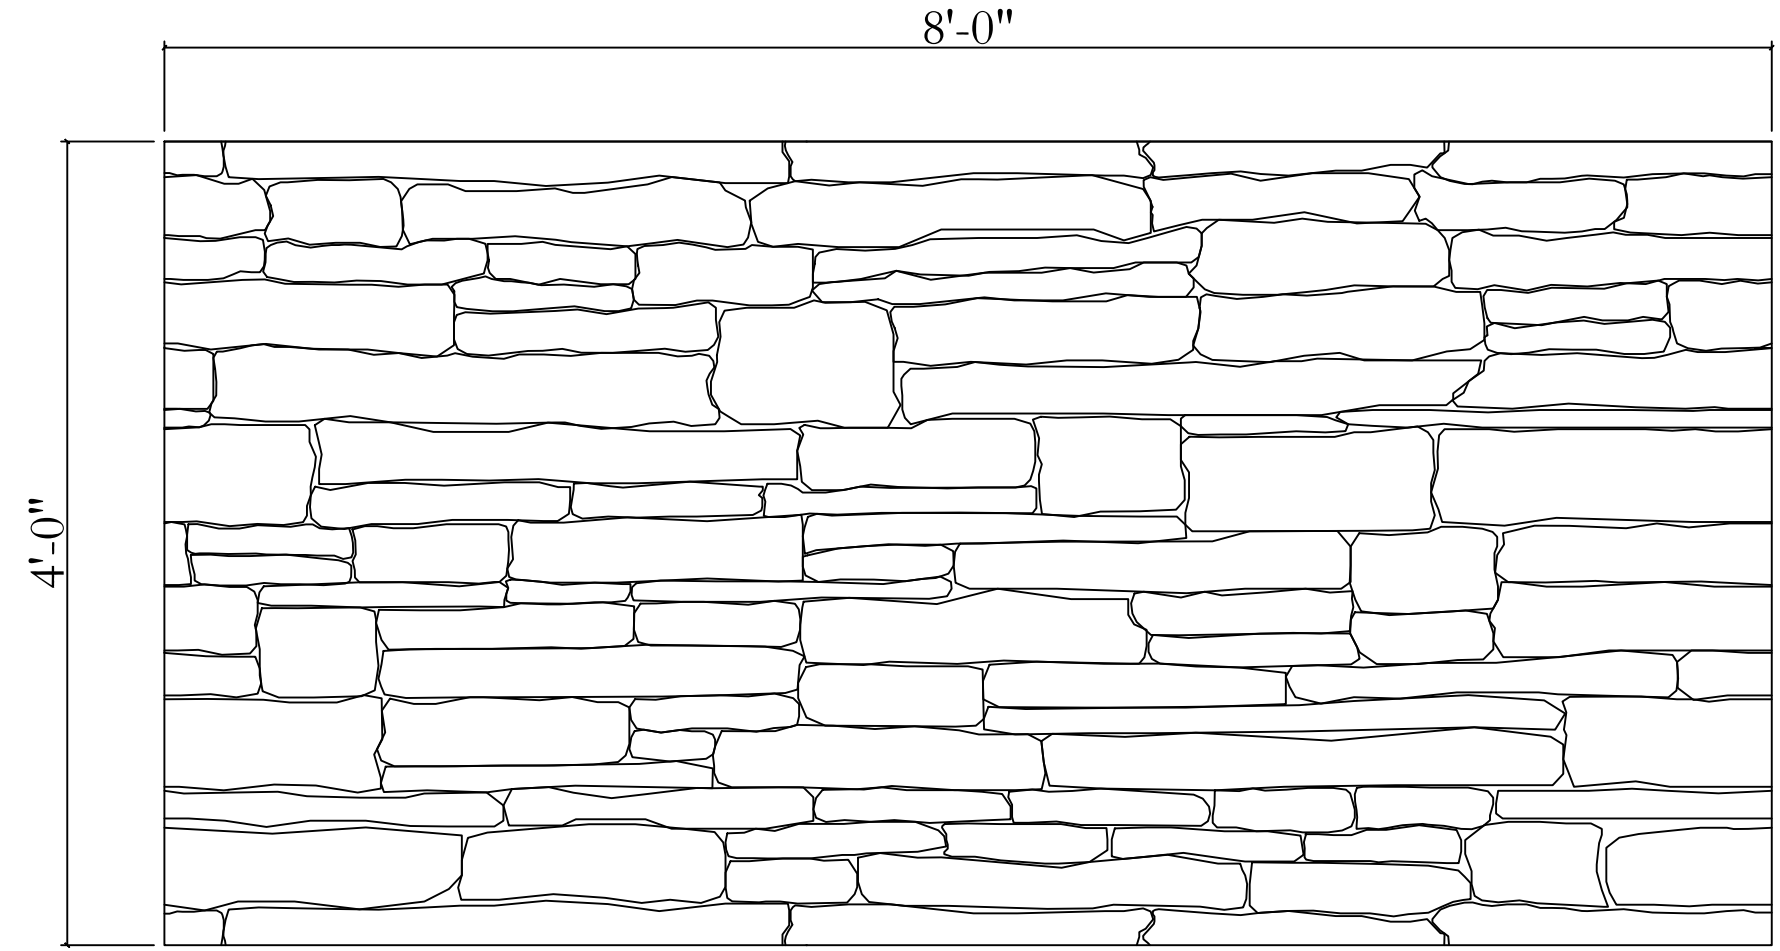
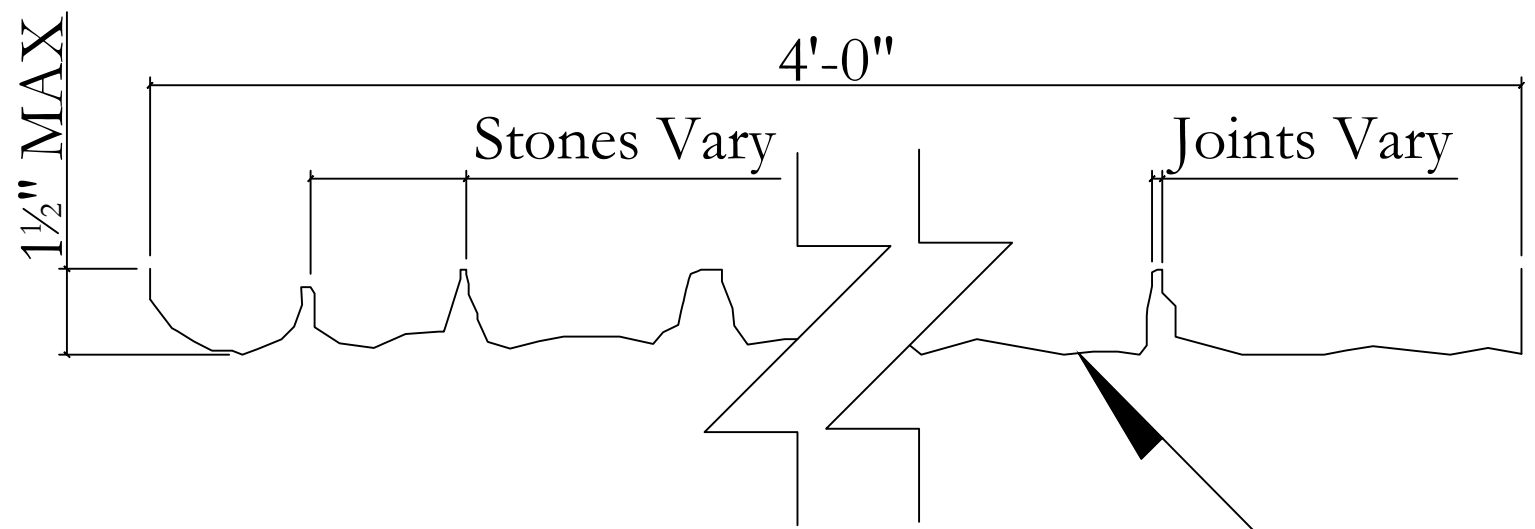
ITEM # 308218

Drystack 1 1/2" Relief. Stone Layout Will Vary

.080 HIPS Formliner

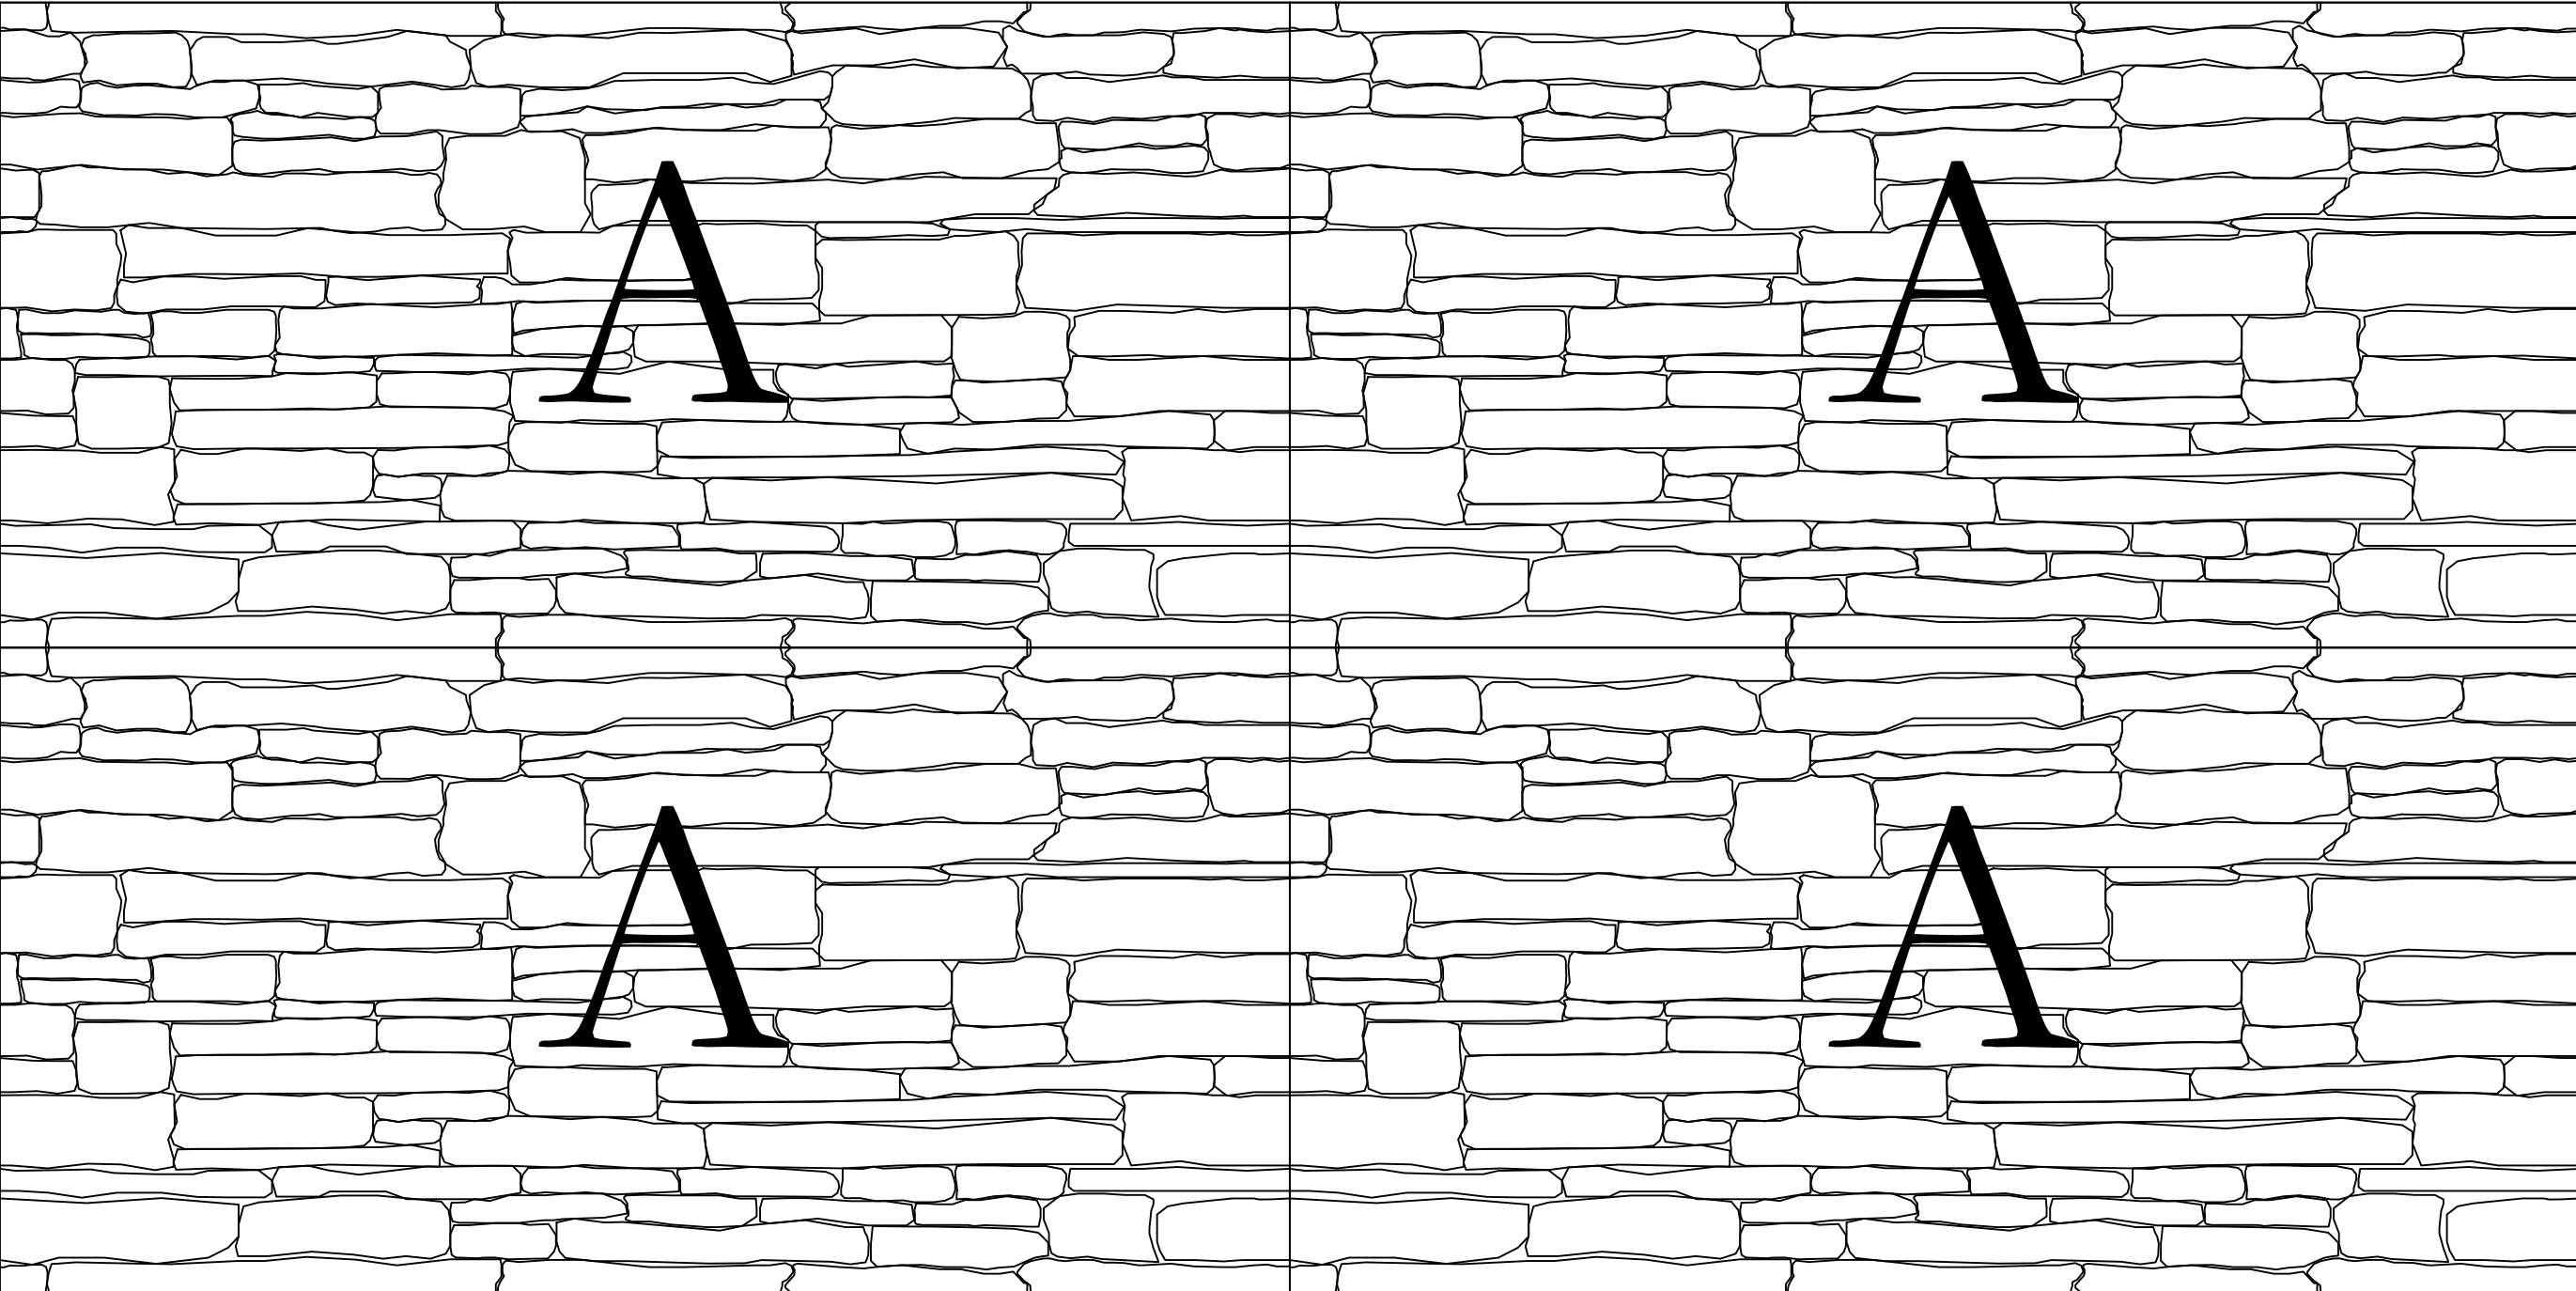
ITEM # 308218

16'-0"

8'-0"

A noticeable seam will occur if not properly sealed when stacking liners.
