Customer:  
Job Name:  
Title: #329B 3/8" Rib 2" OC Horizontal

Customer:  
 Job Name:  
 Title: #329B 3/8" Rib 2" OC Horizontal Assembled

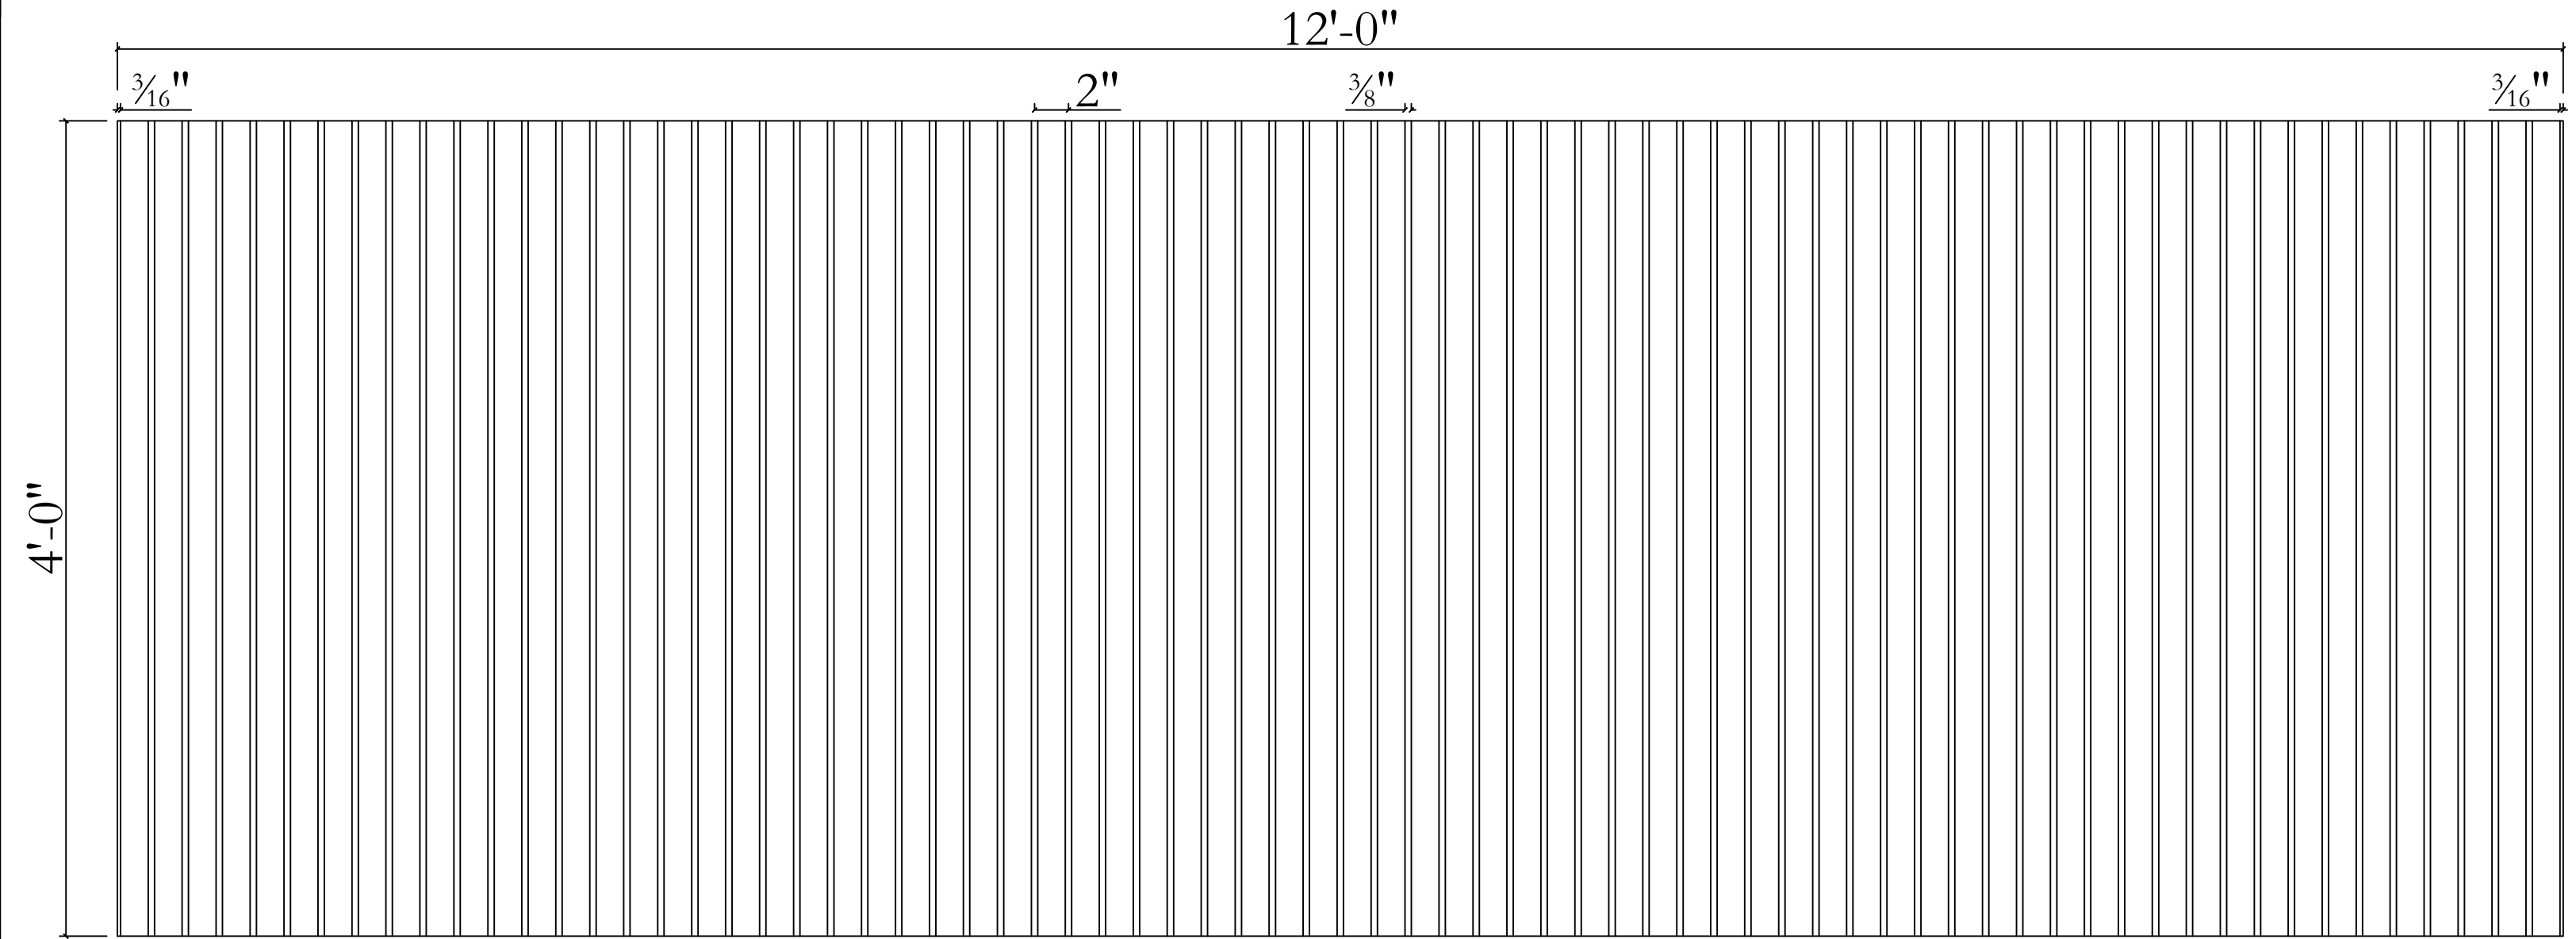
Typical Section  
12'-0"
