ITEM # 309865

Customer:
 Job Name:
 Title: #332 2" Rib 6" OC

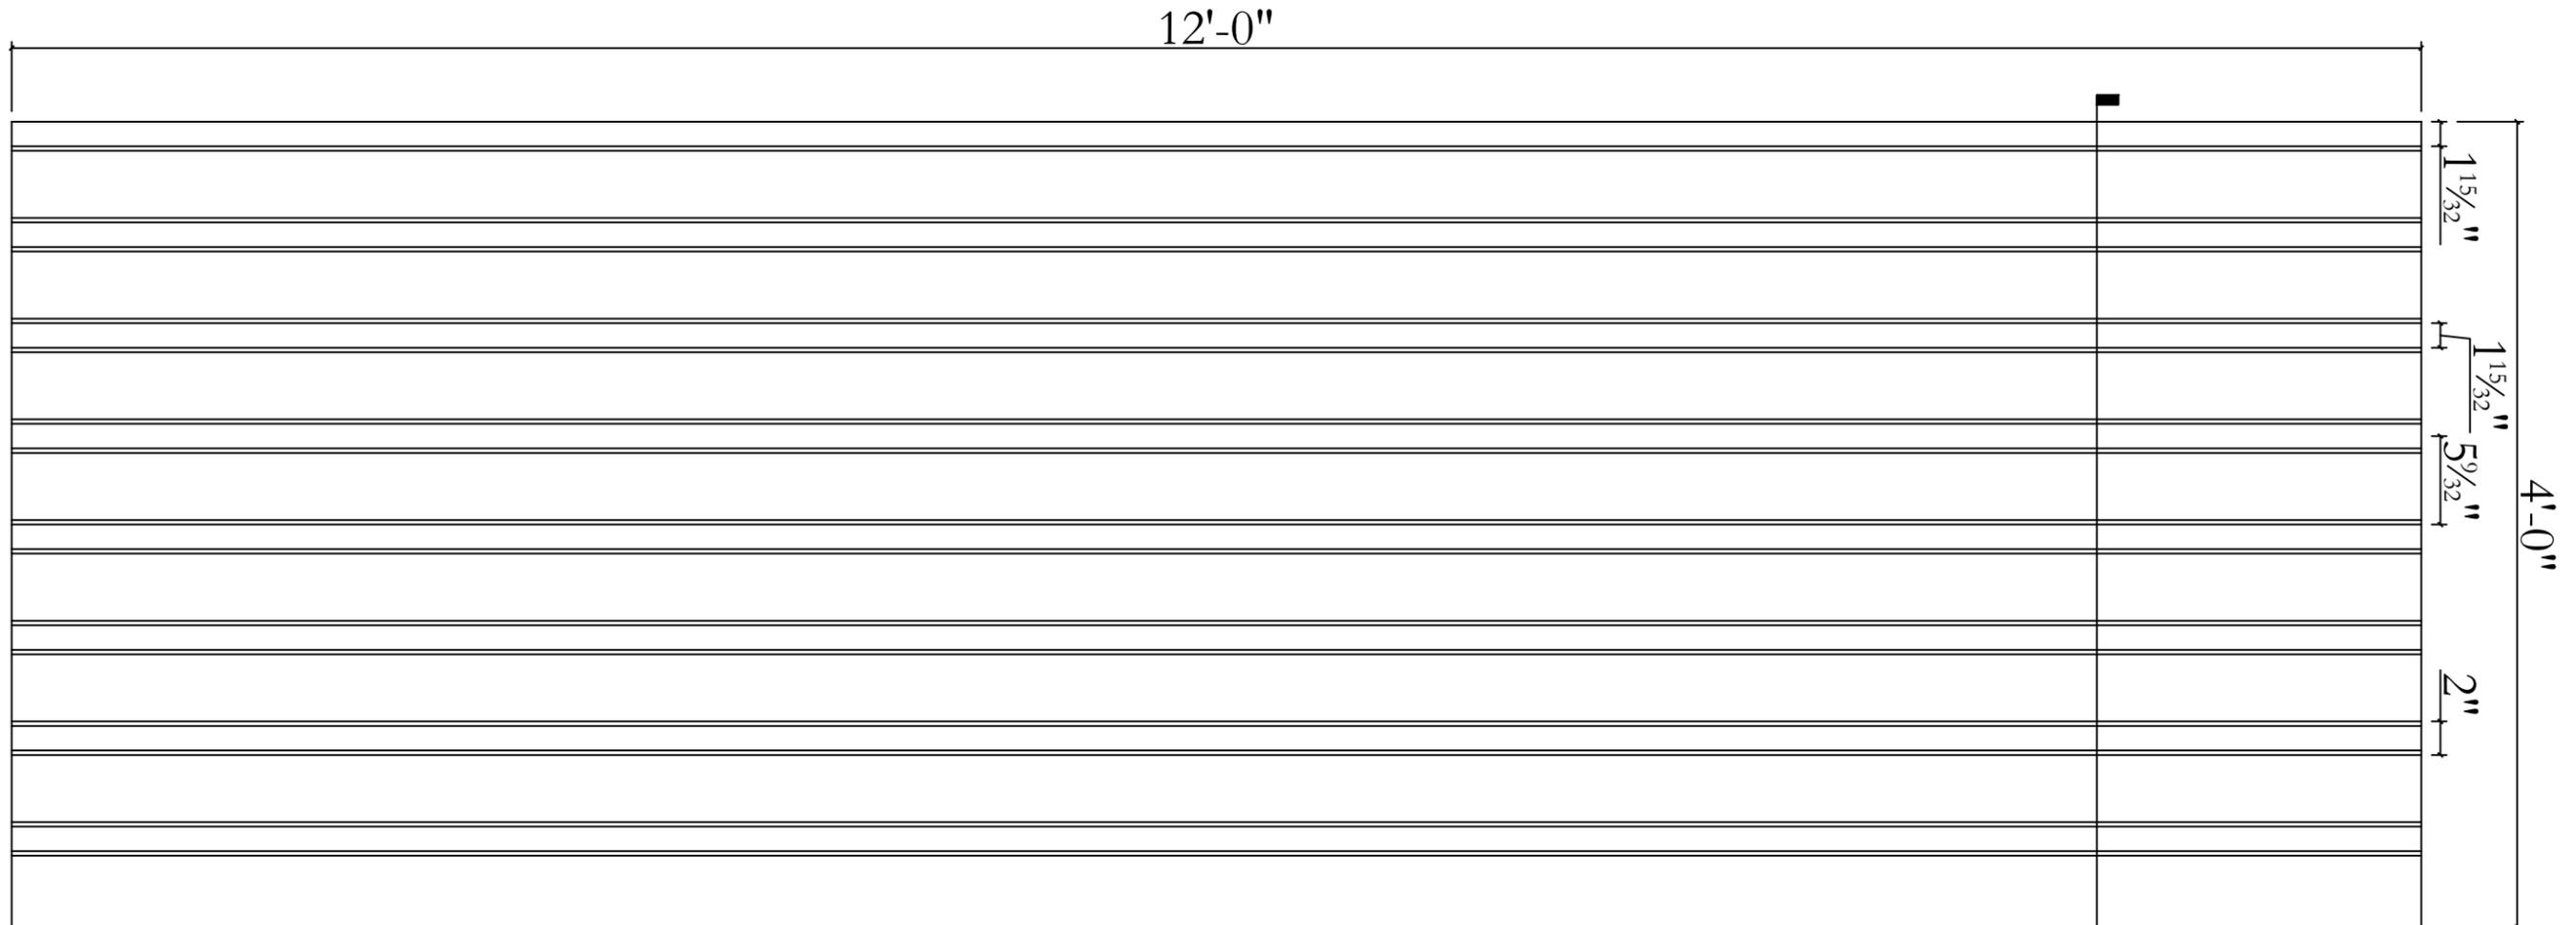
24'-0"

Pattern not designed to stack in 12' direction. A noticeable seam will occur if stacking the liners in 12' direction

A noticeable seam will occur if not properly sealed before pouring

12'-0"

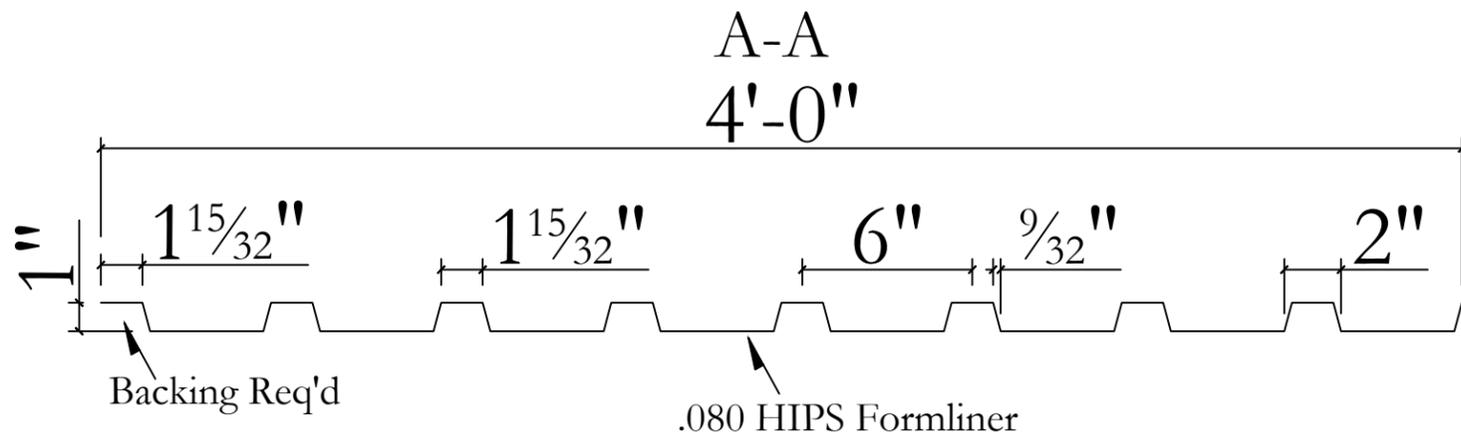
Customer:
Job Name:
Title: #332 2" Rib 6" OC Assembled

A noticeable seam will occur if not properly sealed before pouring

Pattern not designed to stack in 12' direction. A noticeable seam will occur if stacking the liners in 12' direction
